Concerns with the Inspection of Grid-Connected

Solar PV Systems Installed in Alberta

Compiled by
Gordon Howell
Howell Mayhew Engineering
Edmonton

2010 December, 2013 January, 2014 March

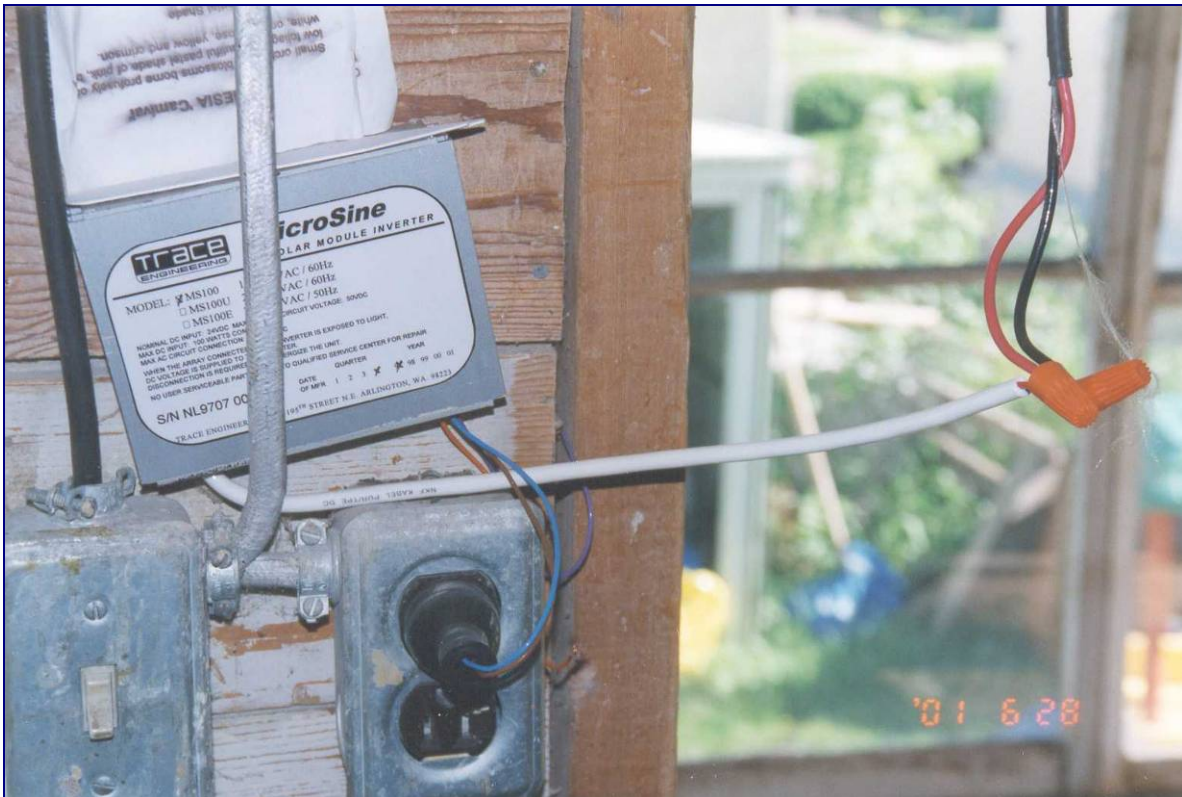
Item #1. Calgary, house

PV array size: 100 W
Electrical specs: $V_{OC} = 70$ VDC, $V_{MP} = 35$ VDC, $V_{inverter} = 120$ VAC
Operating status: removed, not in service
Inspection status: guerrilla PV system installed in 2001, never inspected
Installed by: homeowner

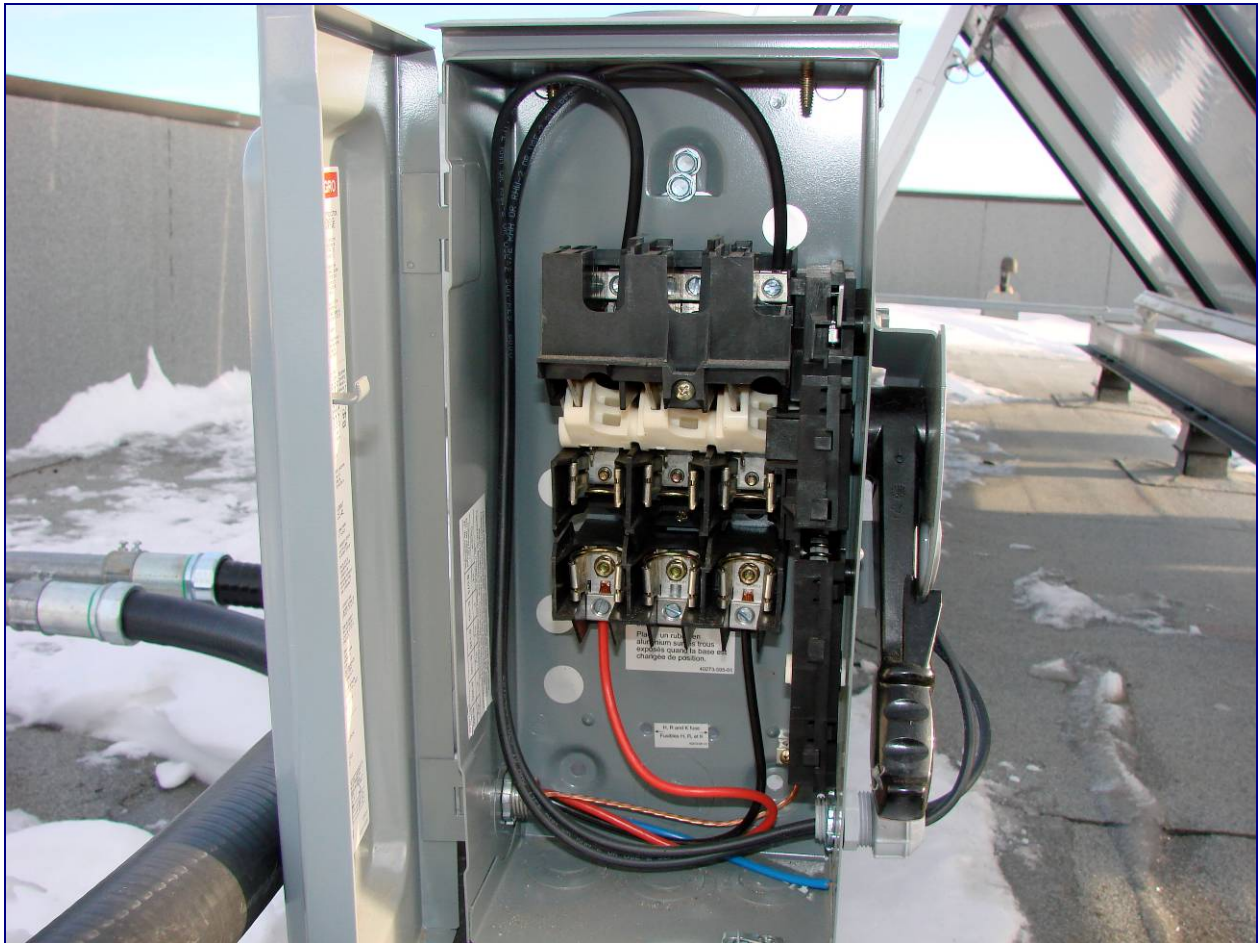
Item #2. Edmonton, municipal building (same PV system as in Item #3, Item #7, Item #11, Item #12, Item #23, Item #24)

PV array size: 1 kW

Electrical specs: $V_{oc} = 343$ to 429 VDC, $V_{MP} = 279$ VDC, $V_{inverter} = 208$ VAC

Operating status: in service since 2008

Inspection status: inspected, passed

Installed by: HVAC contractor installing PV systems

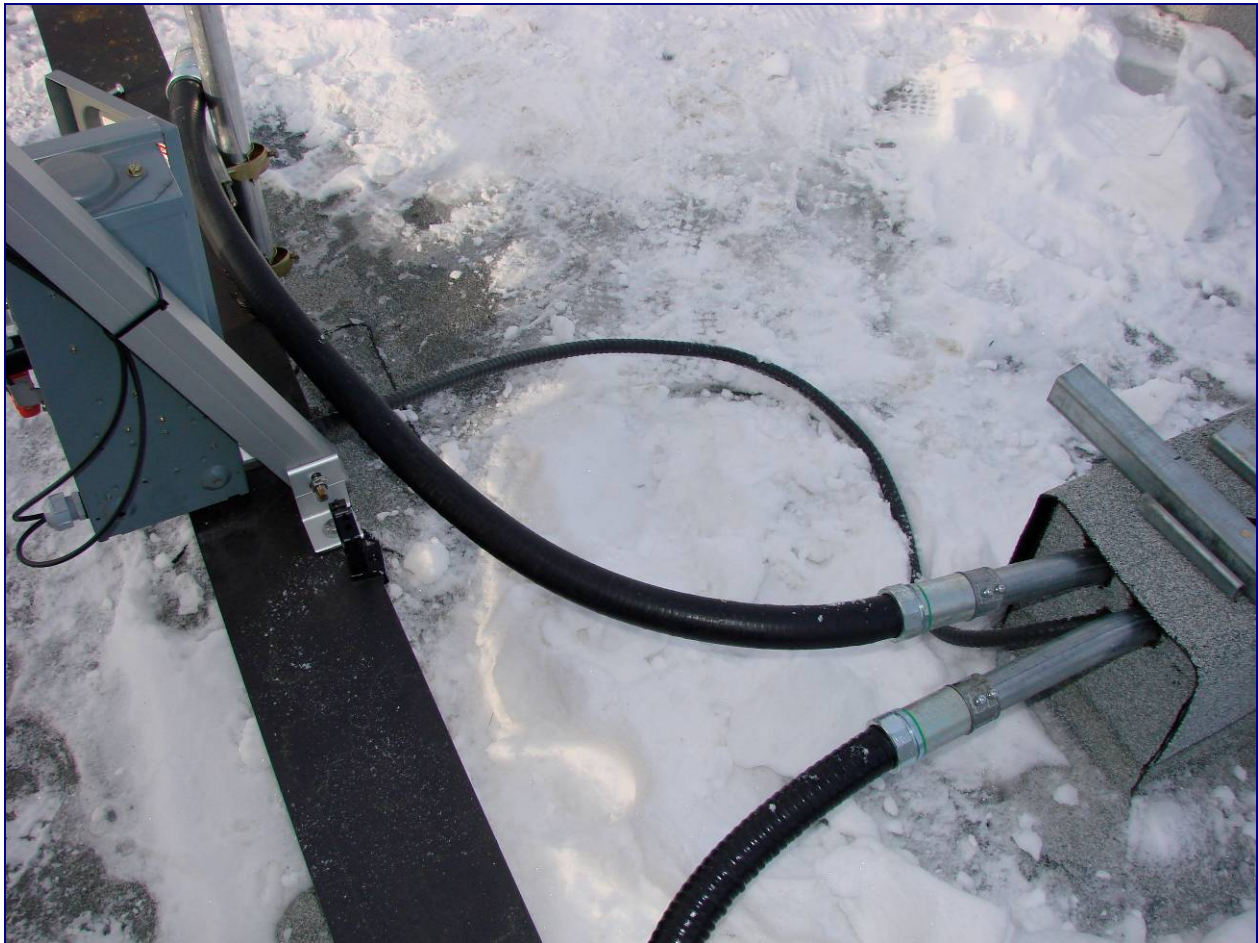
Item #3. Edmonton, municipal building (same PV system as in Item #2, Item #7, Item #11, Item #12, Item #23, Item #24)

PV array size: 1 kW

Electrical specs: $V_{oc} = 343$ to 429 VDC, $V_{MP} = 279$ VDC, $V_{inverter} = 208$ VAC

Operating status: in service since 2008

Inspection status: inspected, passed

Installed by: HVAC contractor installing PV systems

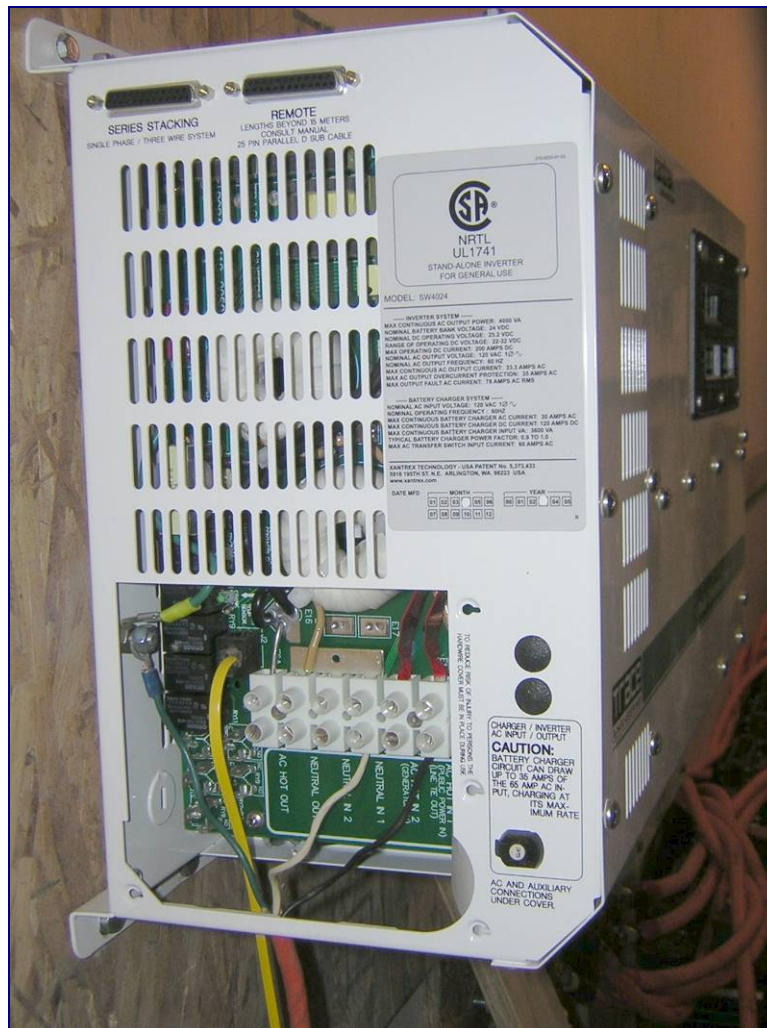
Item #4. Edmonton, house

- PV array size: 2.9 kW
- Electrical specs: Vbattery = 24 VDC, Vinverter = 120 VAC
- Operating status: refused by Supply Authority
- Inspection status: installation had not been completed at the time of the photo
- Installed by: electrical contractor, not PV qualified
- Comments: Dealers in Edmonton and Calgary refused to refund the product or deal with the manufacturing issues. The inverter had to be sent back to the manufacturer to be replaced by a new one.

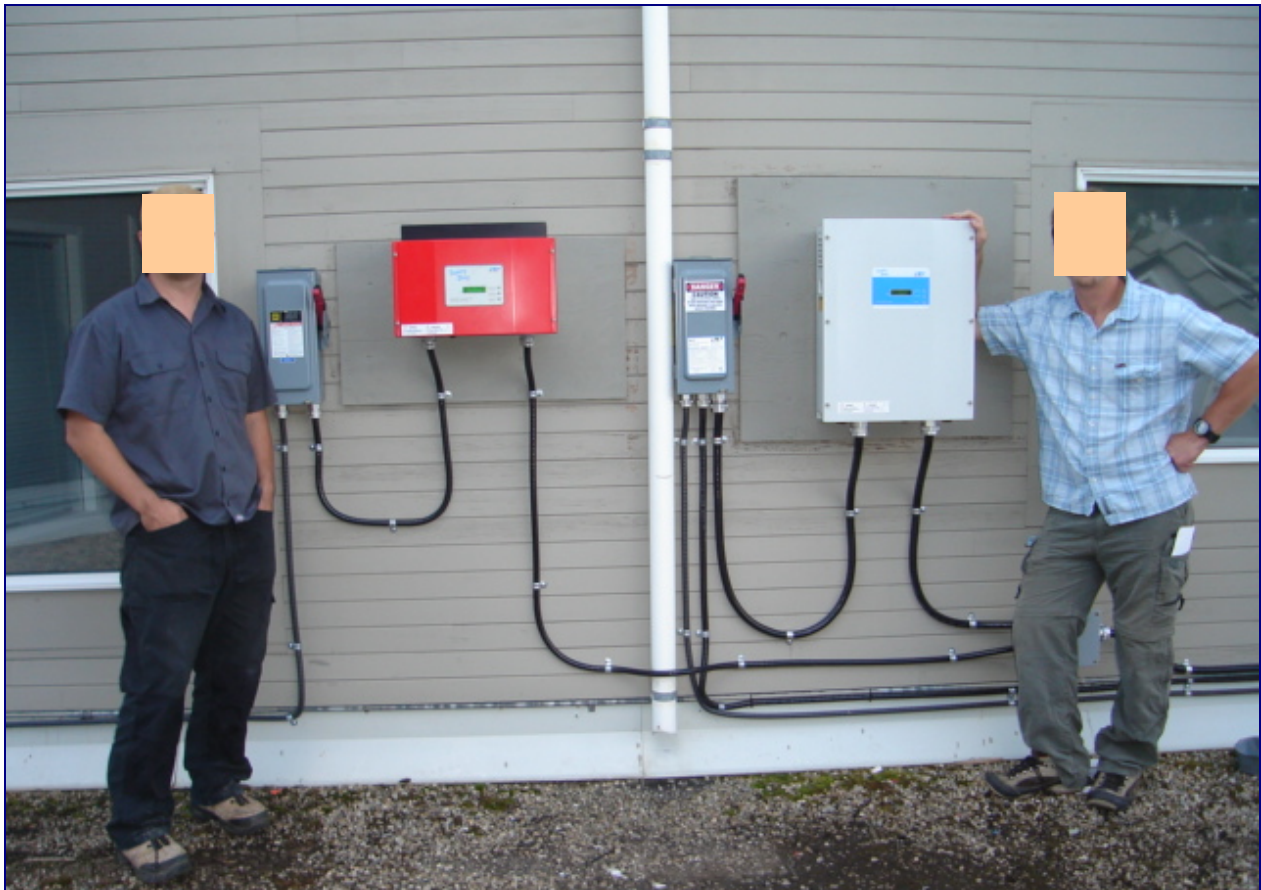
Item #5. Edmonton, house

PV array size: 8 kW
Electrical specs: Inverter = 240 VAC
Operating status: operating since 2006
Inspection status: Inspected, passed
Installed by: electrical contractor specializing in PV systems

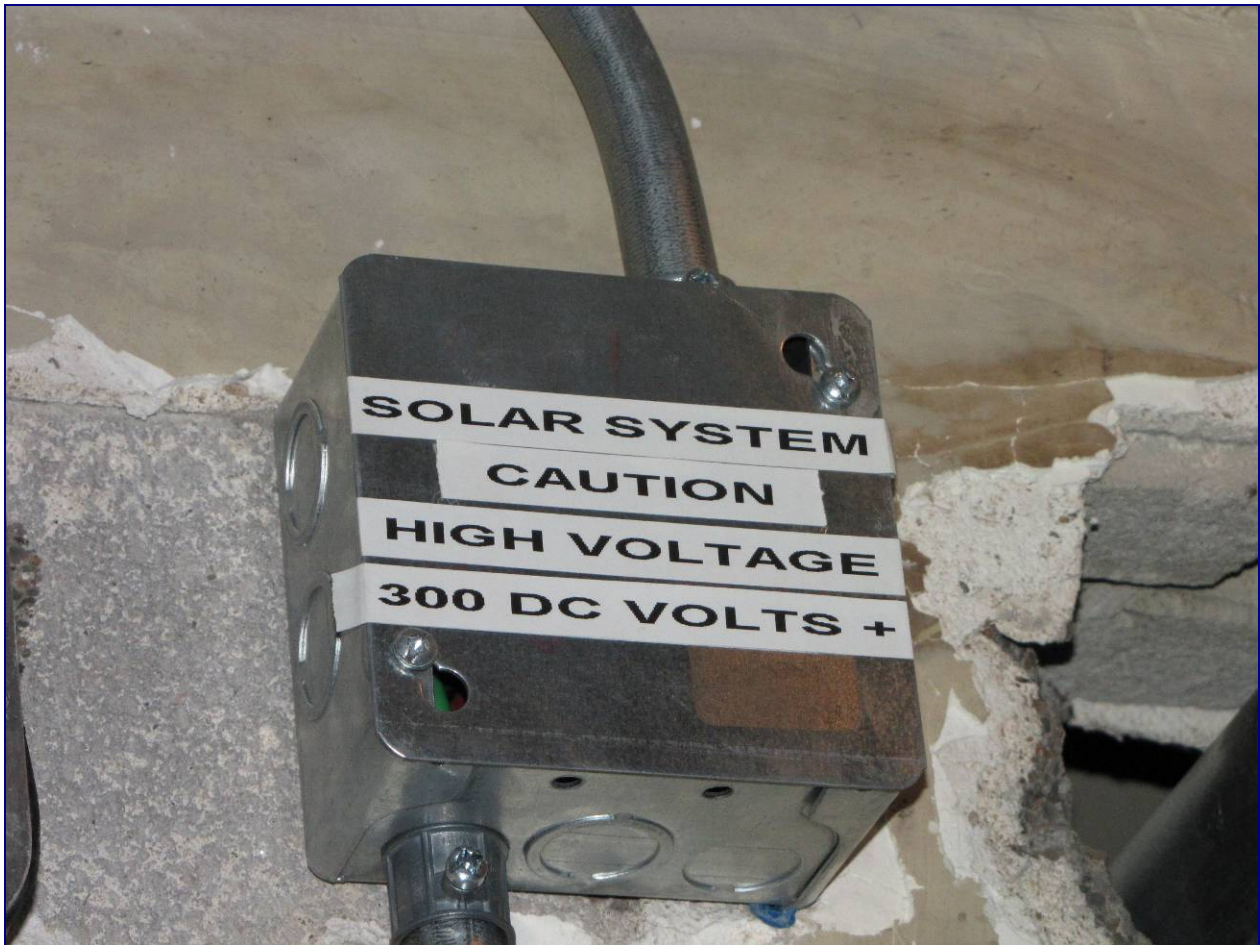
Item #6. Edmonton, commercial building (same PV system as in Item #18)

PV array size: 2 kW
Electrical specs: VInverter = 240 VAC
Operating status: operating since 2008
Inspection status: inspected, passed
Installed by: electrical contractor specializing in PV systems

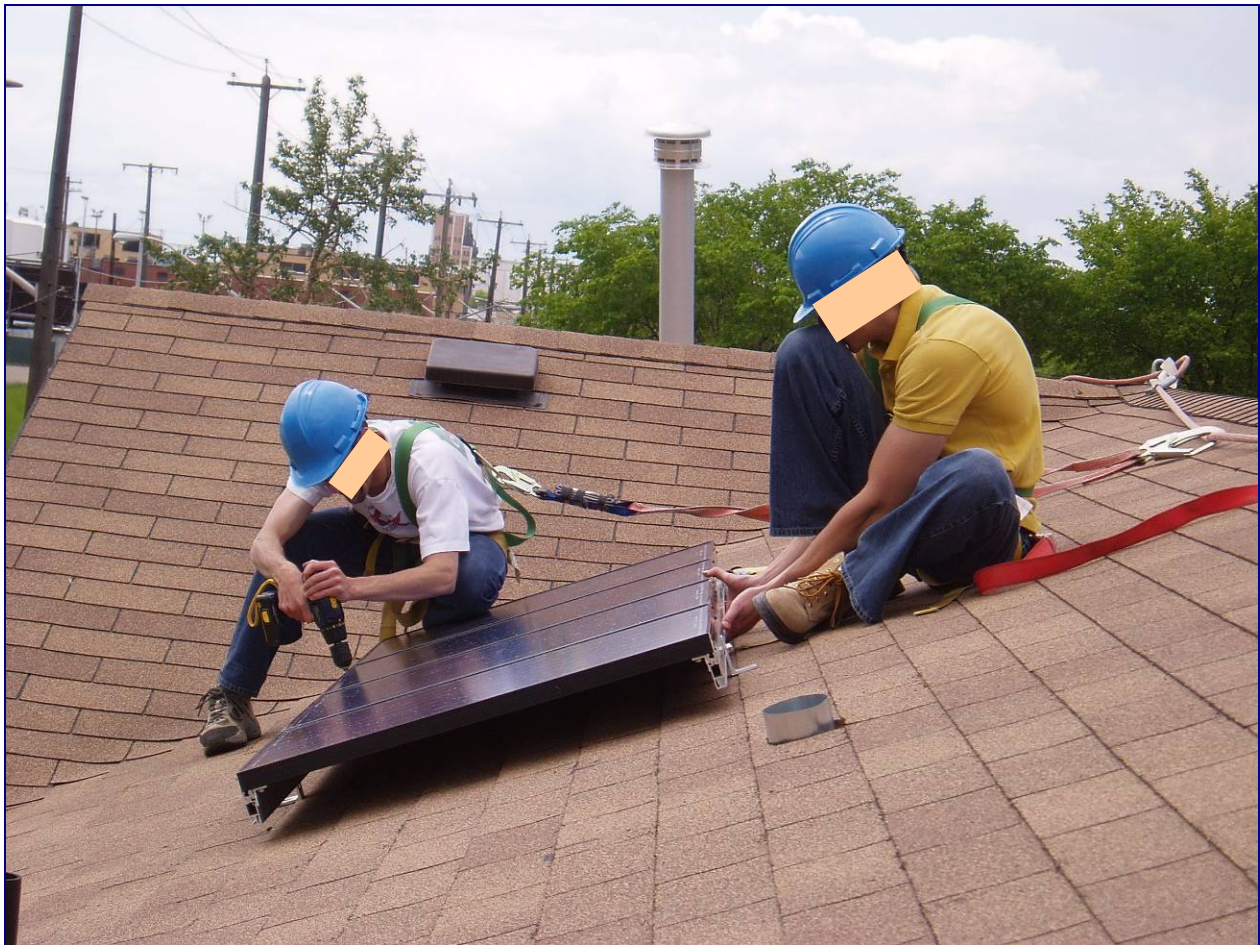
Item #10. Edmonton, house

PV array size: 0.6 kW (?)
Electrical specs: Inverter = 120 VAC
Operating status: operating since 2006
Inspection status: inspected, passed
Installed by: PV equipment supplier

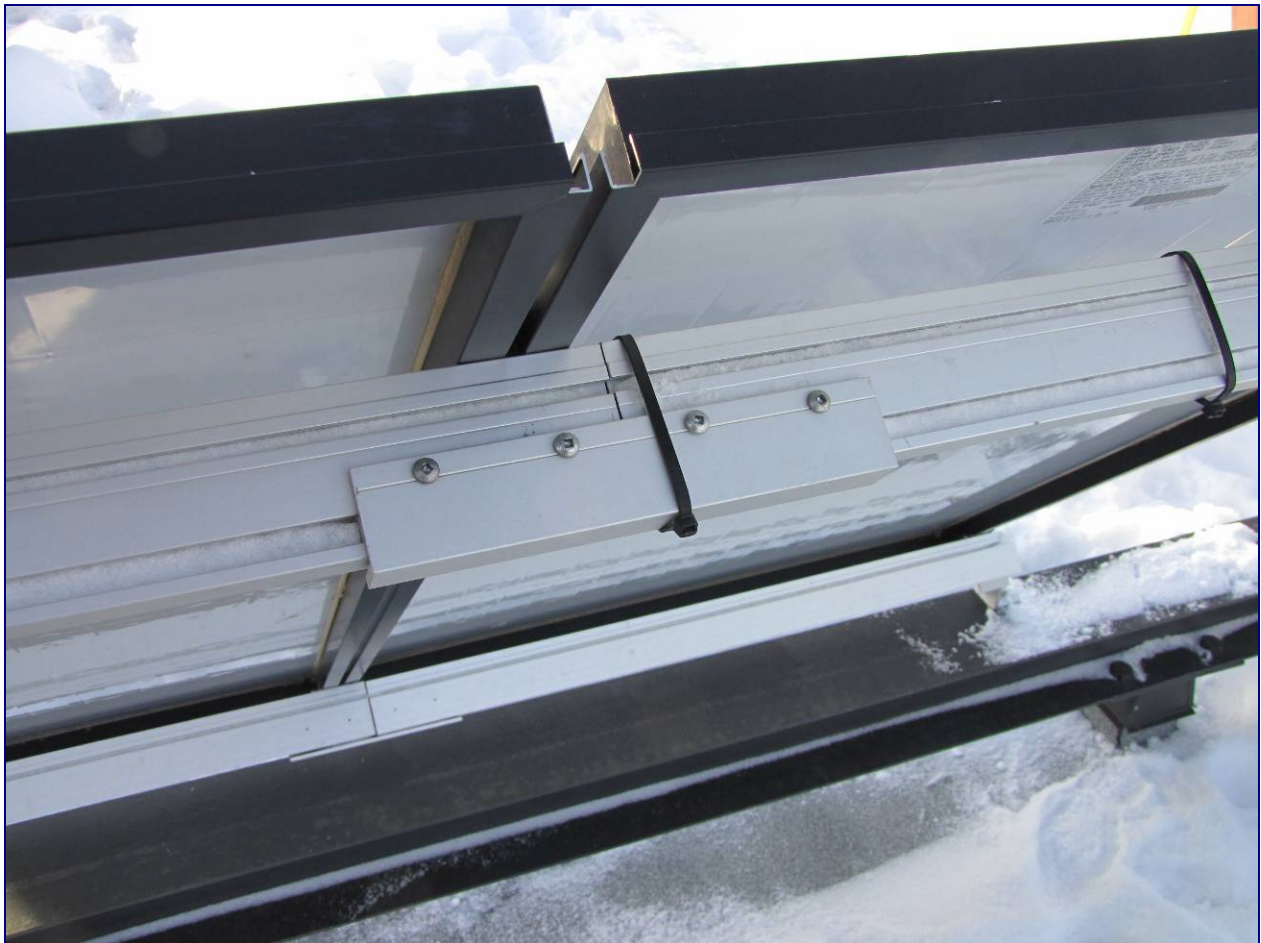
Item #11. Edmonton, municipal building (same PV system as in Item #2, Item #3, Item #7, Item #12, Item #23, Item #24)

PV array size: 1 kW
Electrical specs: $V_{oc} = 343$ to 429 VDC, $V_{MP} = 279$ VDC, $V_{inverter} = 208$ VAC
Operating status: in service since 2008
Inspection status: inspected, passed
Installed by: HVAC contractor installing PV systems

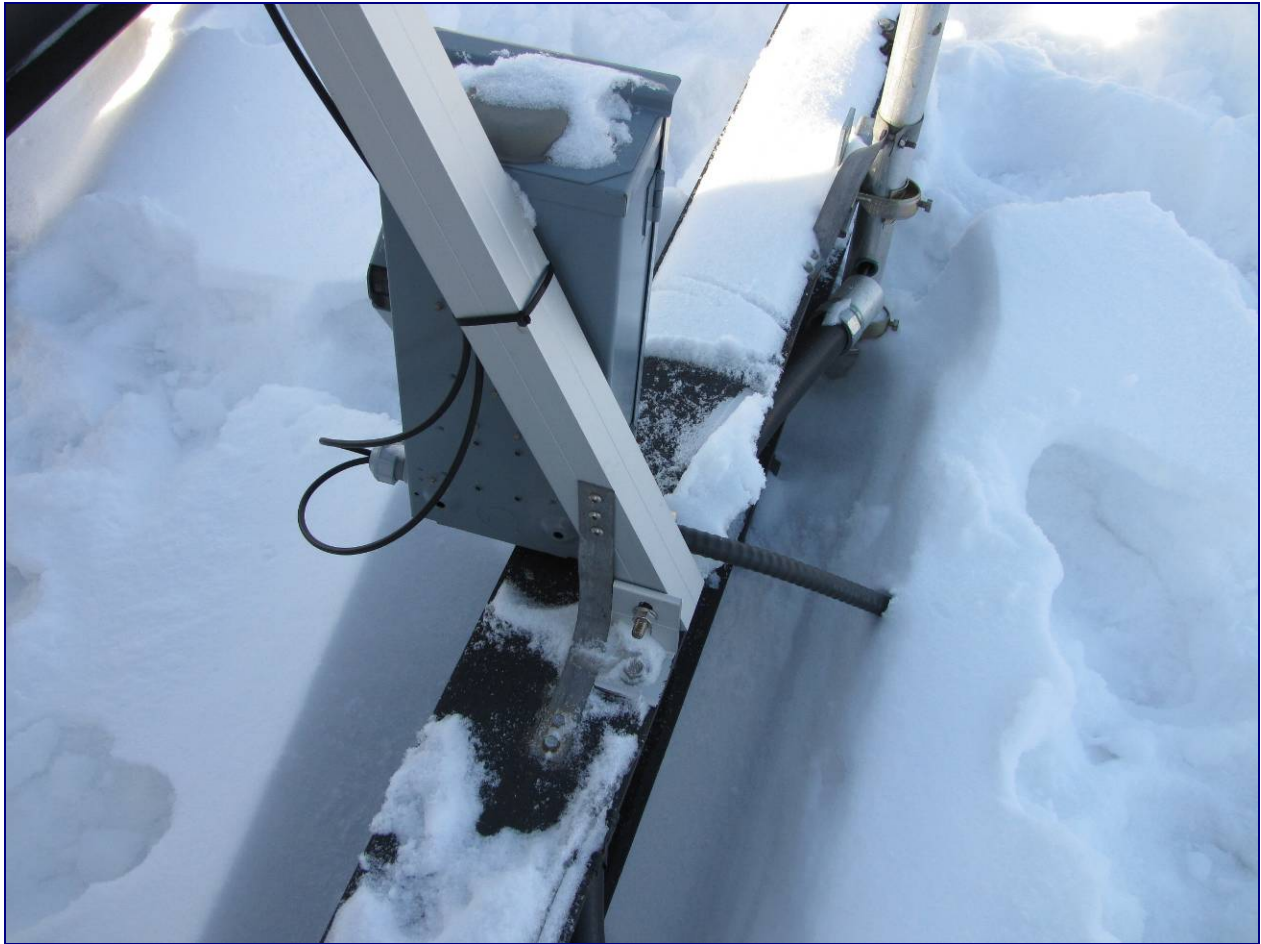
Item #12. Edmonton, municipal building (same PV system as in Item #2, Item #3, Item #7, Item #11, Item #23, Item #24)

PV array size: 1 kW
Electrical specs: Voc = 343 to 429 VDC, V_{MP} = 279 VDC, Vinverter = 208 VAC
Operating status: in service since 2008
Inspection status: inspected, passed
Installed by: HVAC contractor installing PV systems

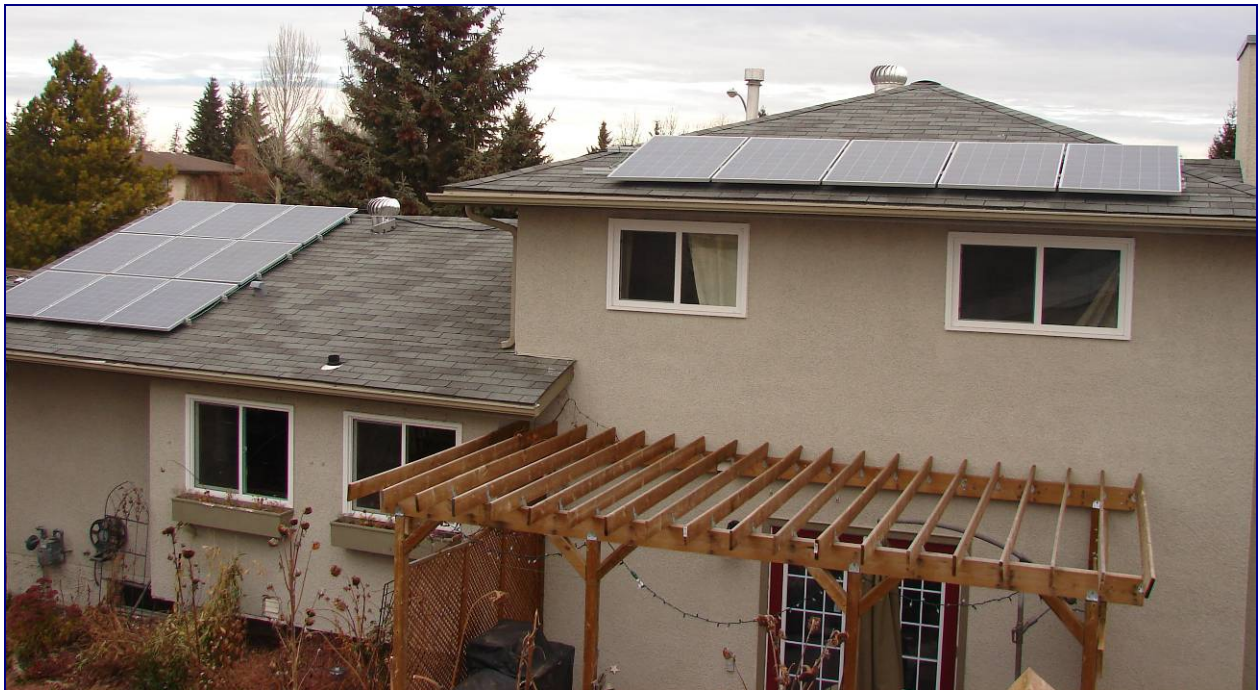
Item #13. Edmonton, house

PV array size: 2 kW?
Electrical specs: VInverter = 240 VAC
Operating status: operating since 2010 (?)
Inspection status: inspected, passed
Installed by: homeowner (?)

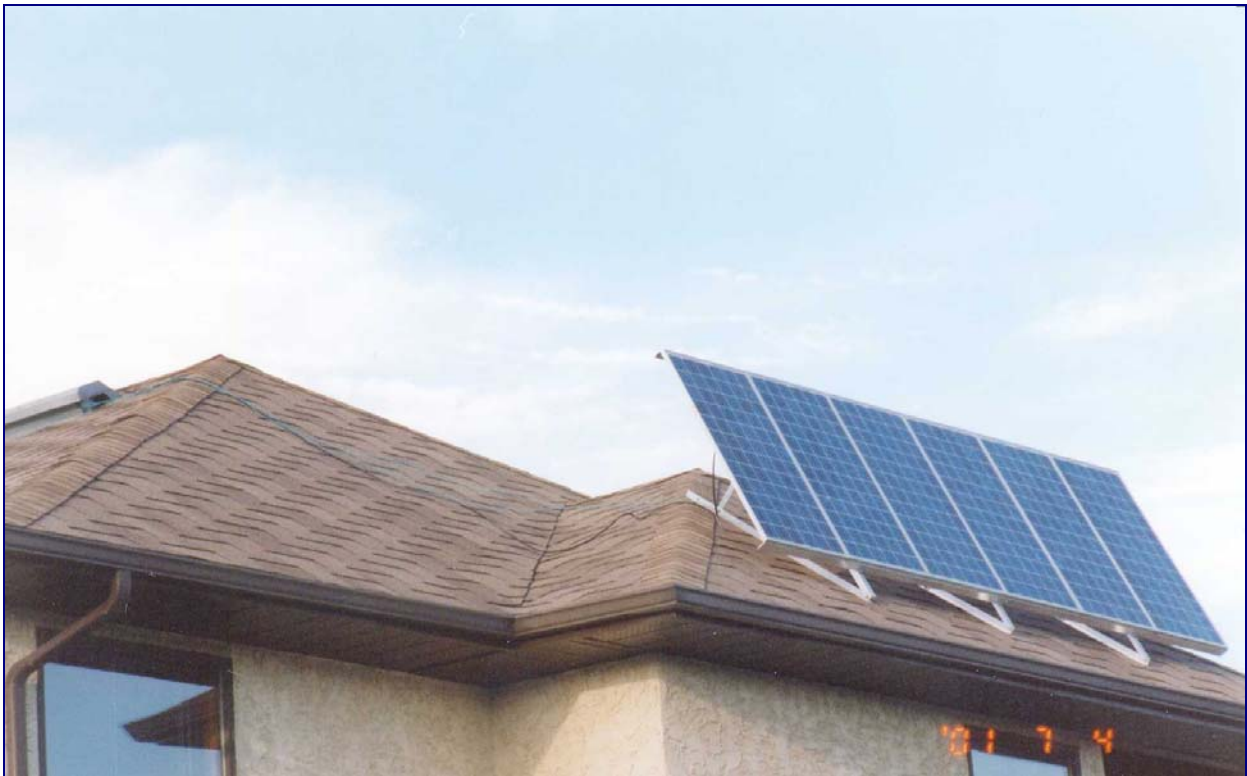
Item #15. Calgary, house (same PV system as in Item #14)

PV array size: 2 kW (?)
Electrical specs: VInverter = 120 VAC
Operating status: operating since 1999
Inspection status: likely not inspected
Installed by: homeowner

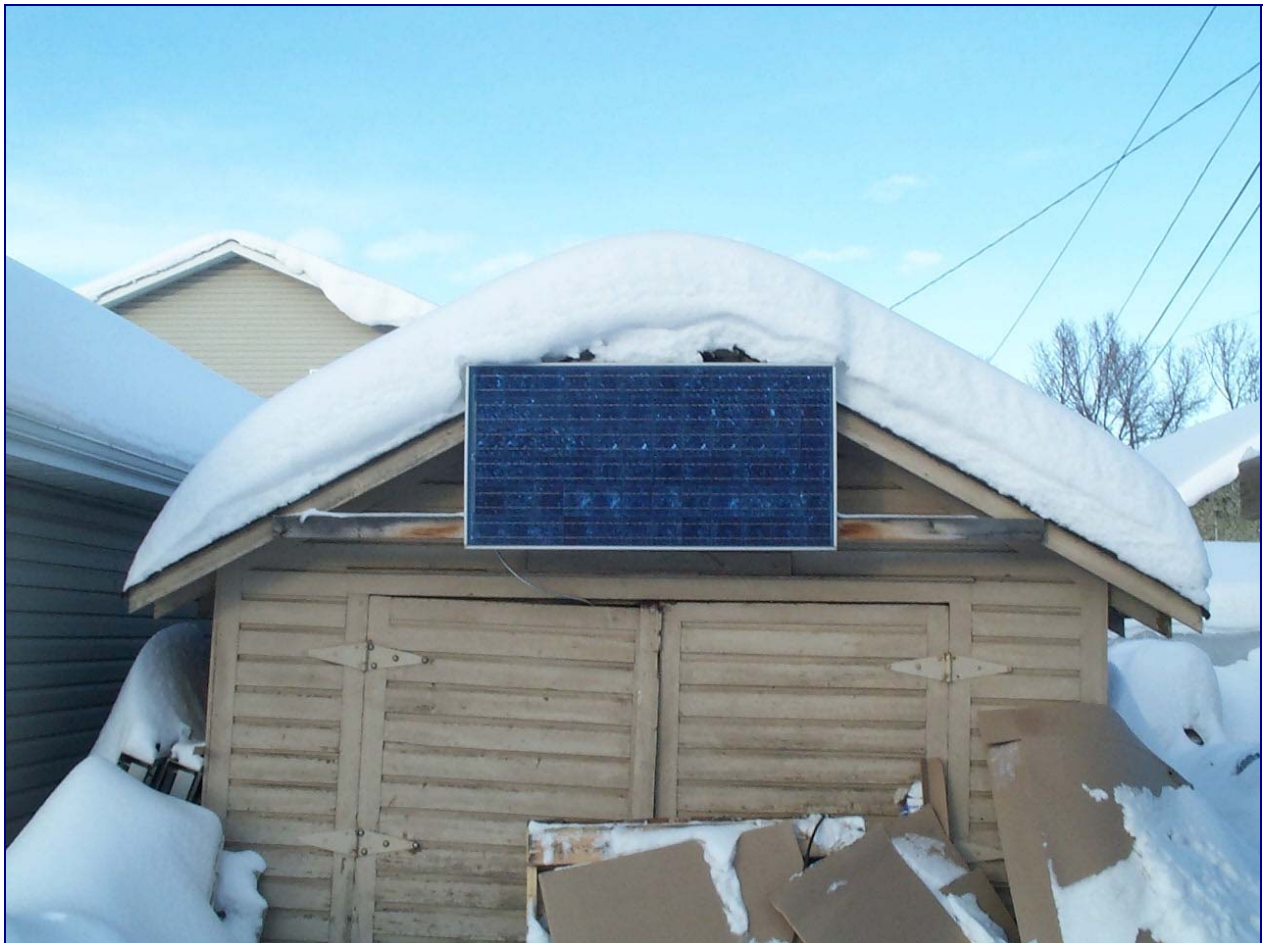
Item #16. Edmonton house

PV array size: not known, 100 W?
Electrical specs: not known
Operating status: not known
Inspection status: likely not inspected
Installed by: homeowner

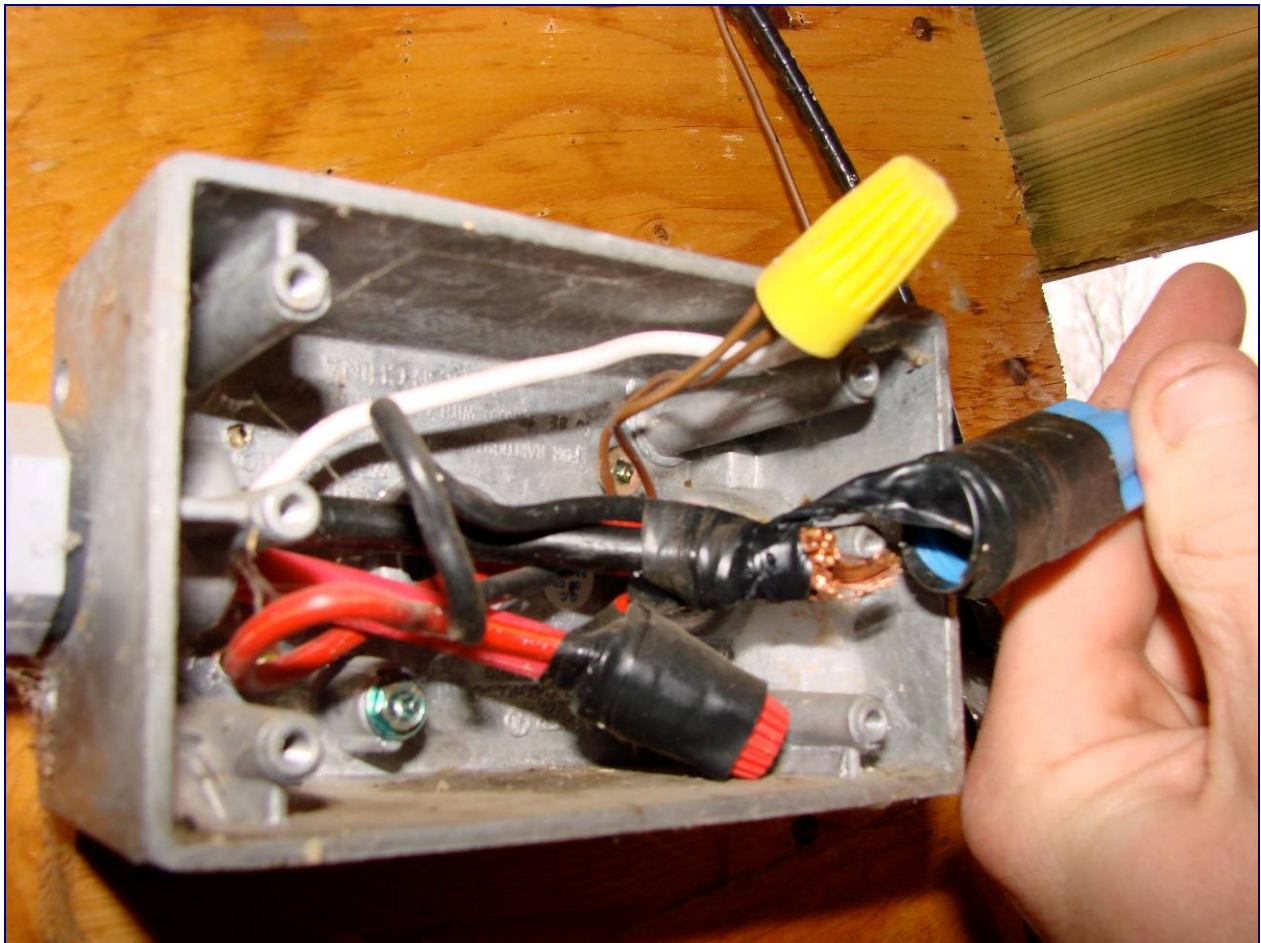
Item #17. City not known, house

PV array size: not known
Electrical specs: not known
Operating status: not known
Inspection status: not known
Installed by: not known

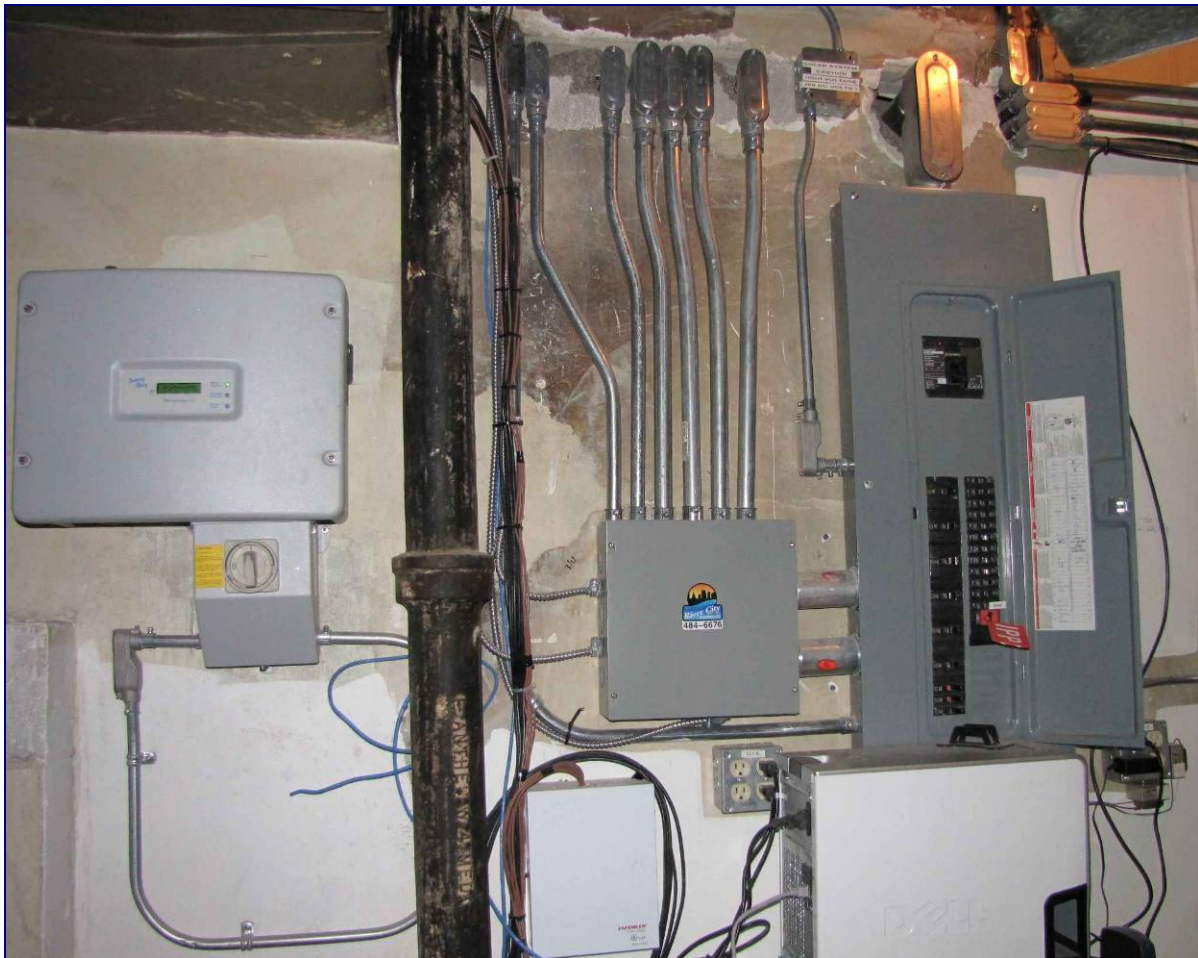
Item #18. Edmonton, commercial building (same PV system as in Item #6)

PV array size: 2 kW (?)
Electrical specs: VInverter = 240 VAC
Operating status: operating since 2008
Inspection status: inspected, passed
Installed by: electrical contractor specializing in PV systems

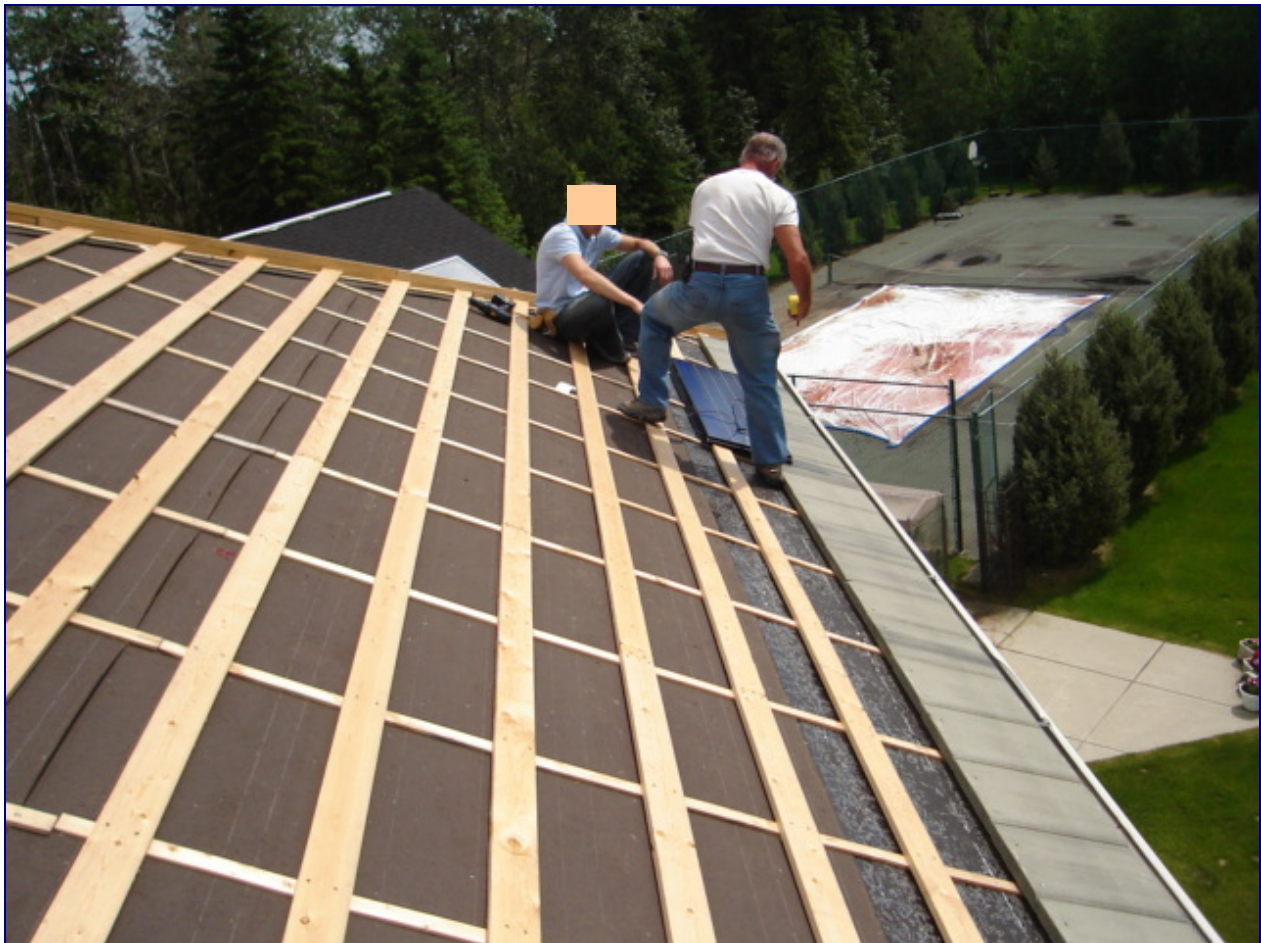
Item #19. Edmonton, house

PV array size: 16 kW (?)
Electrical specs: Vnverter = 240 VAC
Operating status: operating since 2006 (?)
Inspection status: inspected, passed
Installed by: PV equipment supplier

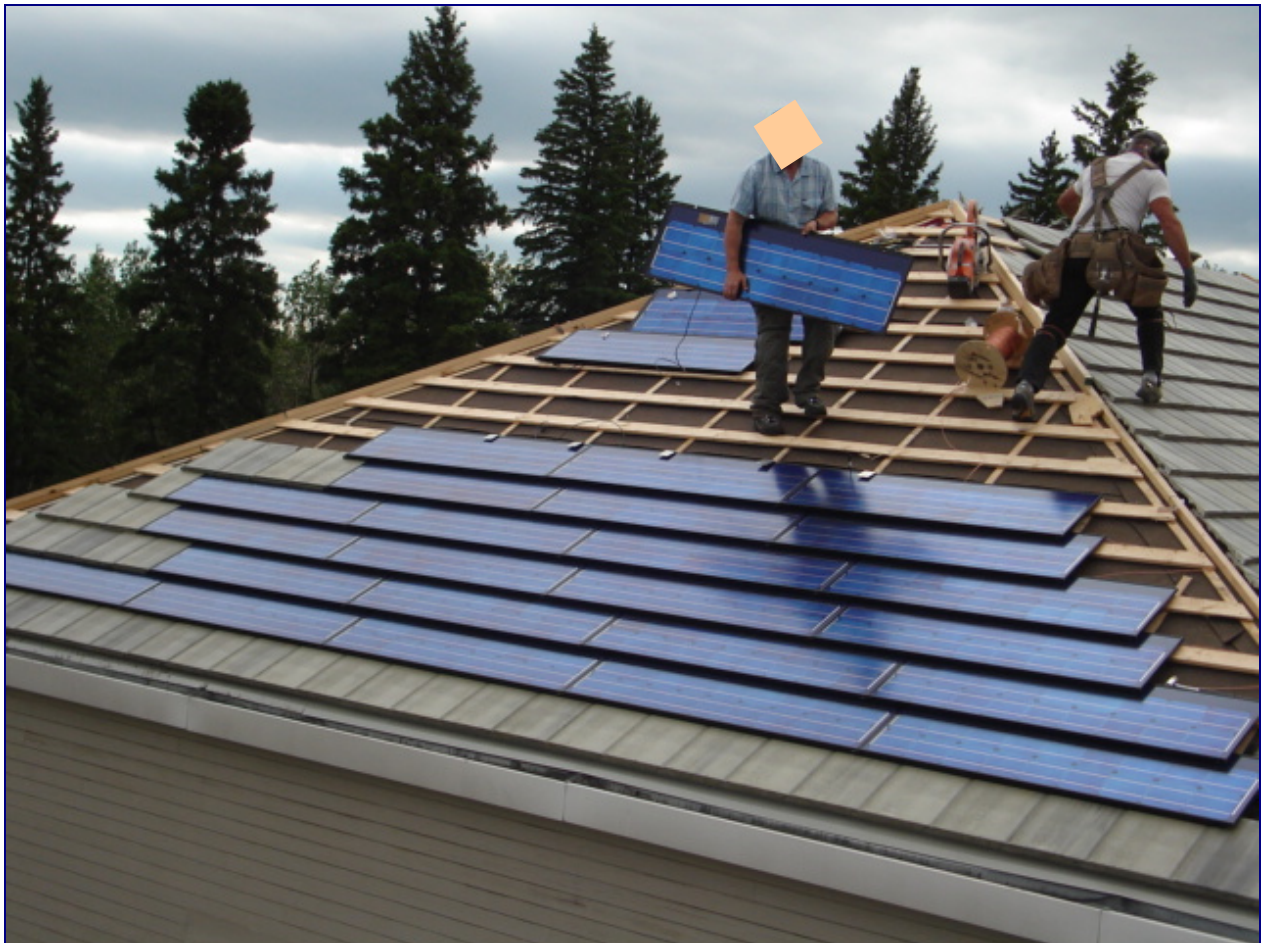
Item #20. Edmonton, house (same PV system as in Item #19)

PV array size: 16 kW (?)
Electrical specs: VInverter = 240 VAC
Operating status: operating since 2006 (?)
Inspection status: inspected, passed
Installed by: PV equipment supplier

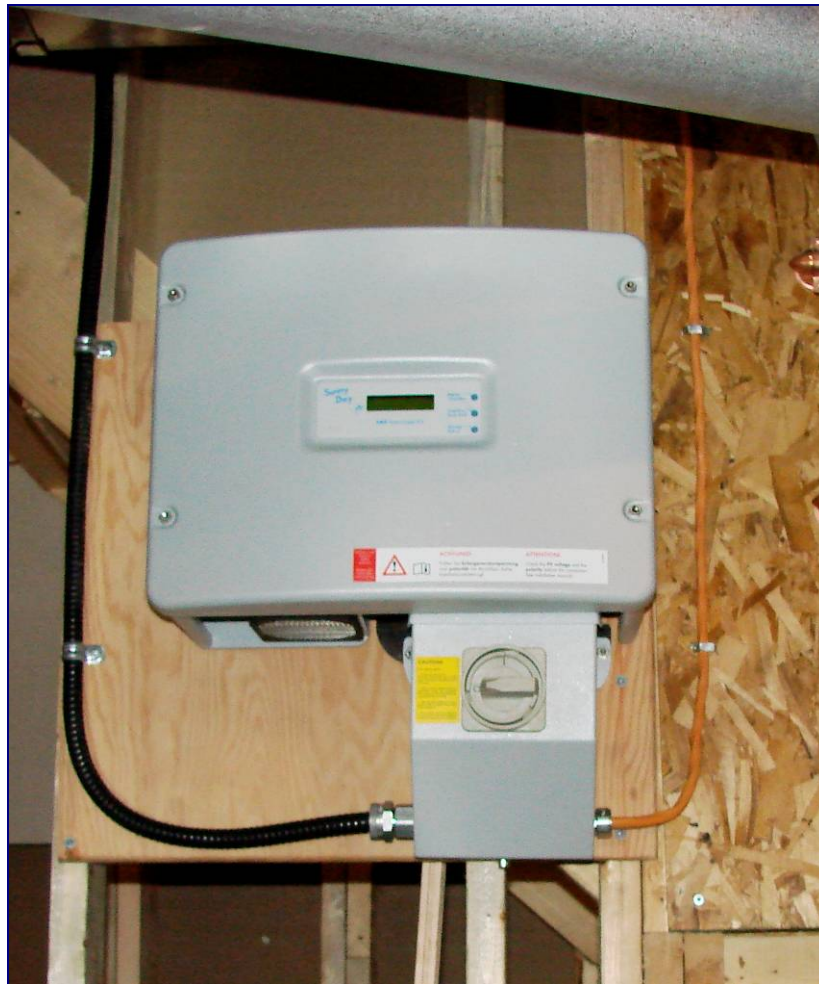
Item #21. Edmonton, house

PV array size: 2.9 kW
Electrical specs: Inverter = 240 VAC
Operating status: operating since 2007 (?)
Inspection status: inspected, passed
Installed by: PV equipment supplier

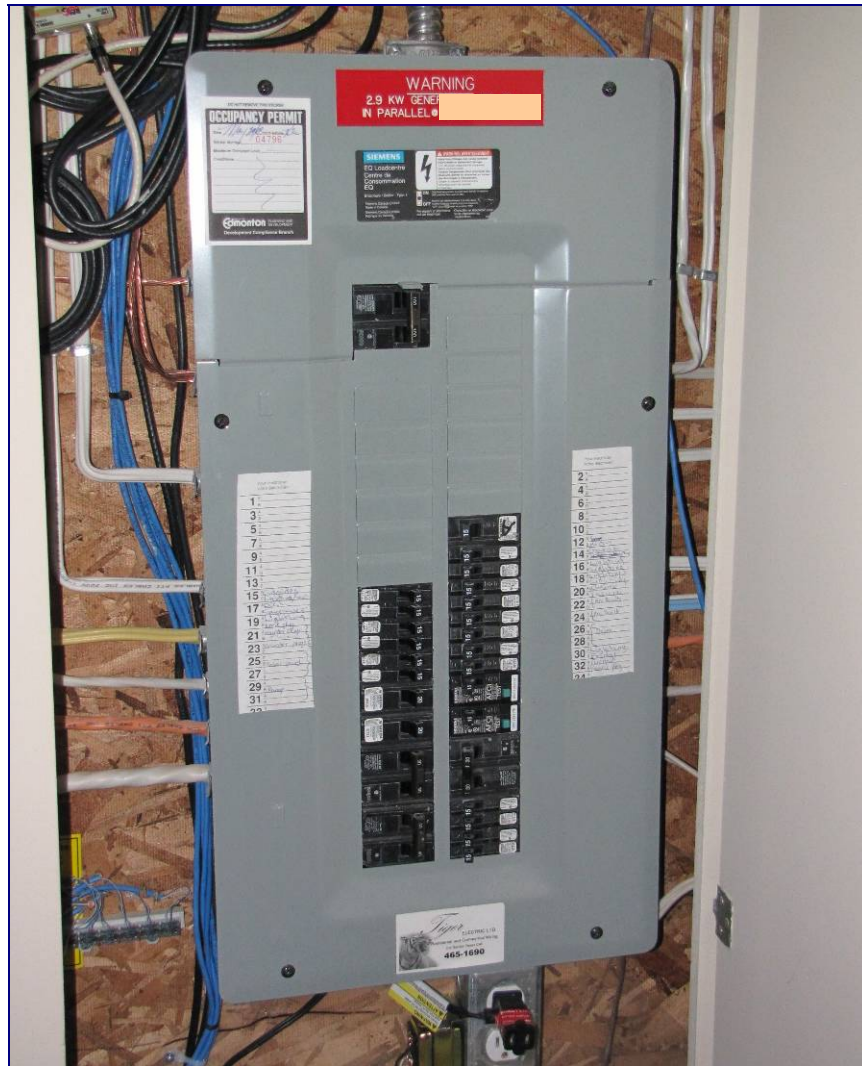
Item #22. Edmonton, house (same PV system as in Item #21)

PV array size: 2.9 kW
Electrical specs: Inverter = 240 VAC
Operating status: operating since 2007 (?)
Inspection status: inspected, passed
Installed by: PV equipment supplier

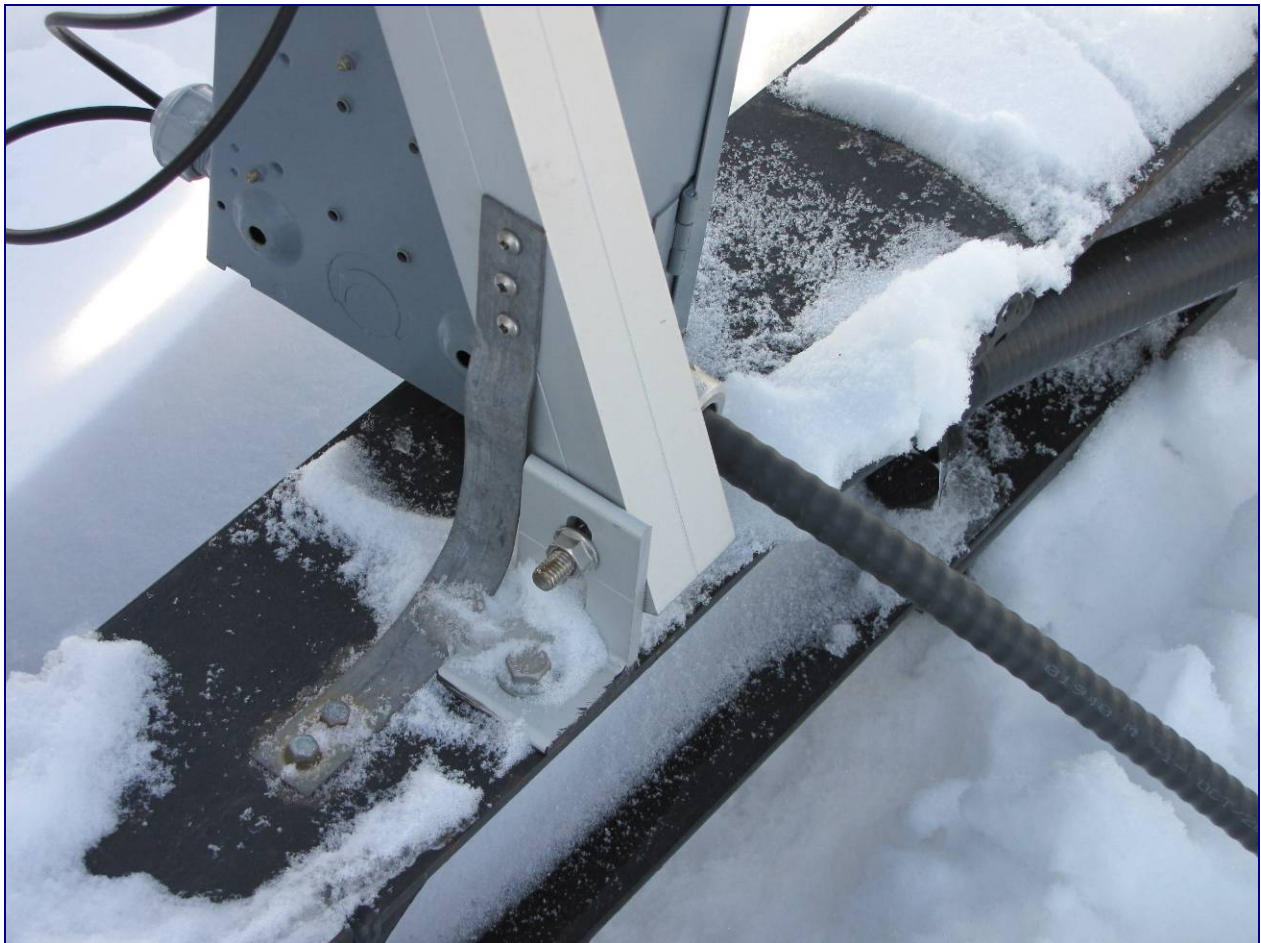
Item #24. Edmonton, municipal building (same PV system as in Item #2, Item #3, Item #7, Item #11, Item #12, Item #23)

PV array size: 1 kW

Electrical specs: Voc = 343 to 429 VDC, V_{MP} = 279 VDC, Vinverter = 208 VAC

Operating status: in service since 2008

Inspection status: inspected, passed

Installed by: HVAC contractor installing PV systems

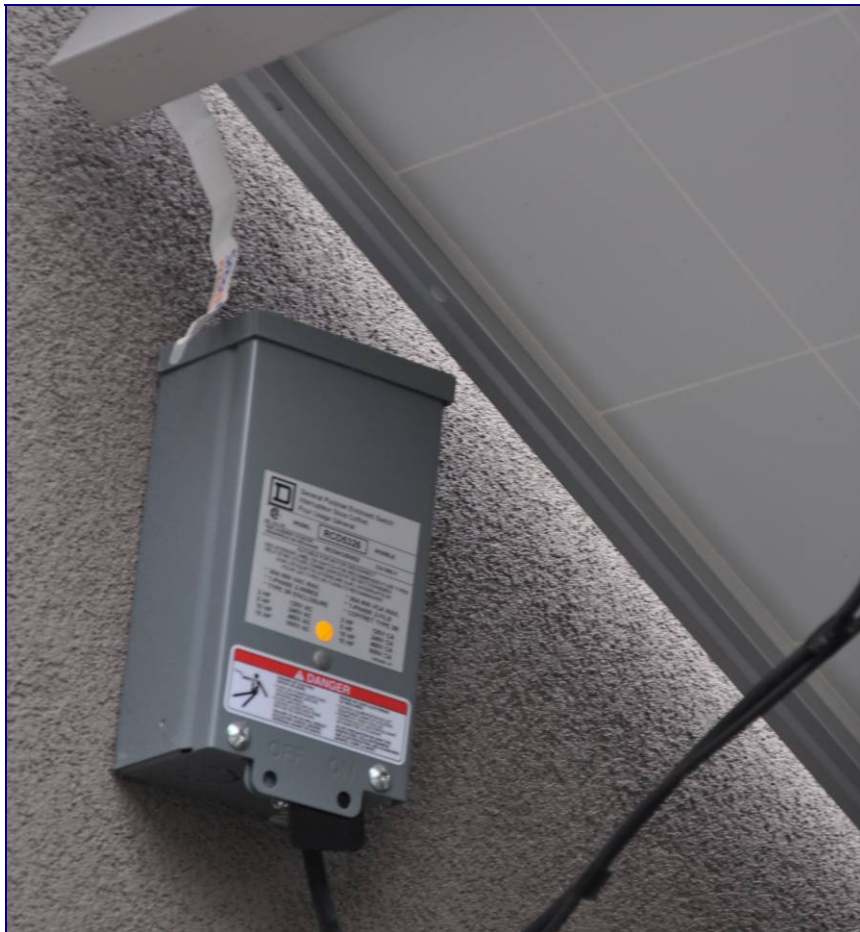
Item #25. Calgary, house (same PV system as in Item #26, Item #27)

PV array size: 2 kW (?)
Electrical specs: VInverter = 240 VAC
Operating status: operating since 2009 (?)
Inspection status: not known
Installed by: electrical contractor, not PV qualified
