Concerns with the Inspection of Grid-Connected

Solar PV Systems Installed in Alberta

Compiled by
Gordon Howell
Howell Mayhew Engineering
Edmonton

2010 December, 2013 January, 2014 March

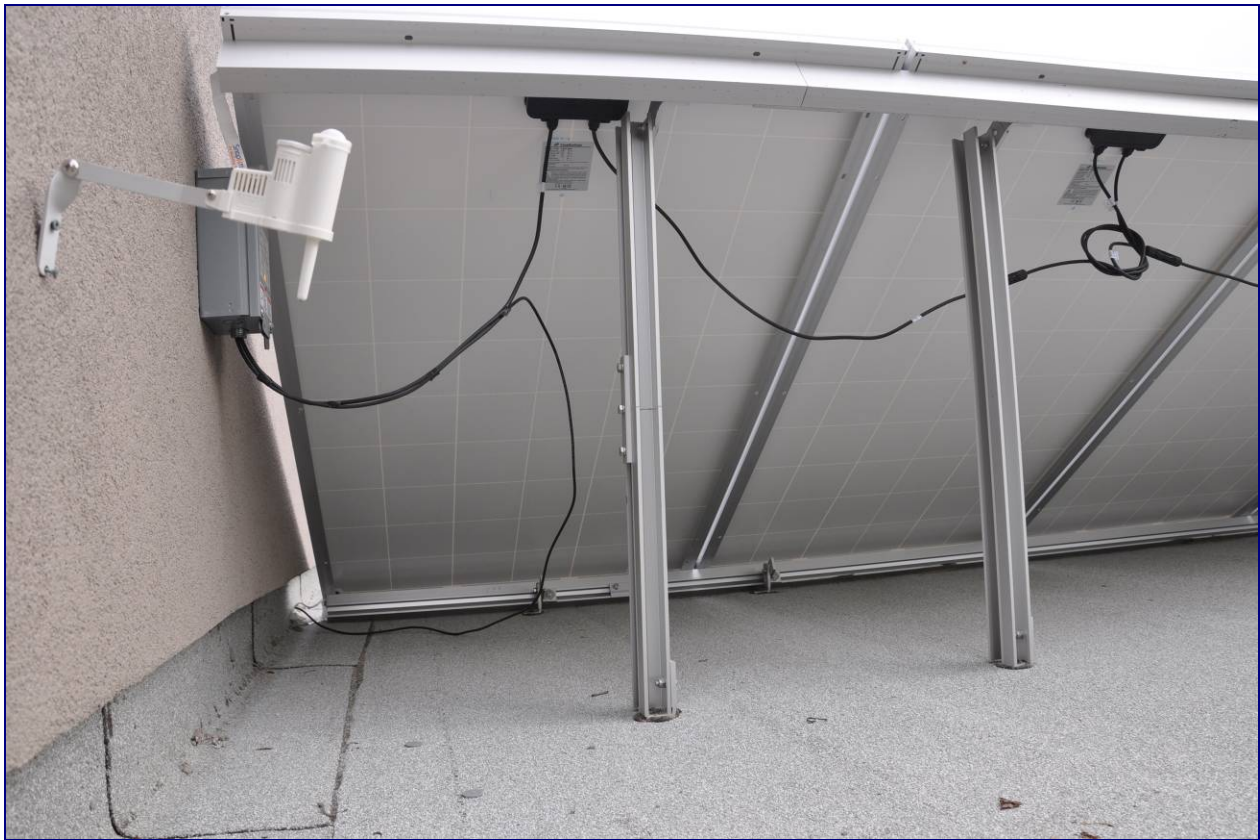
Item #26. Calgary, house (same PV system as in Item #25, Item #27)

PV array size: 2 kW (?)
Electrical specs: Inverter = 240 VAC
Operating status: operating since 2009 (?)
Inspection status: not known
Installed by: electrical contractor, not PV qualified

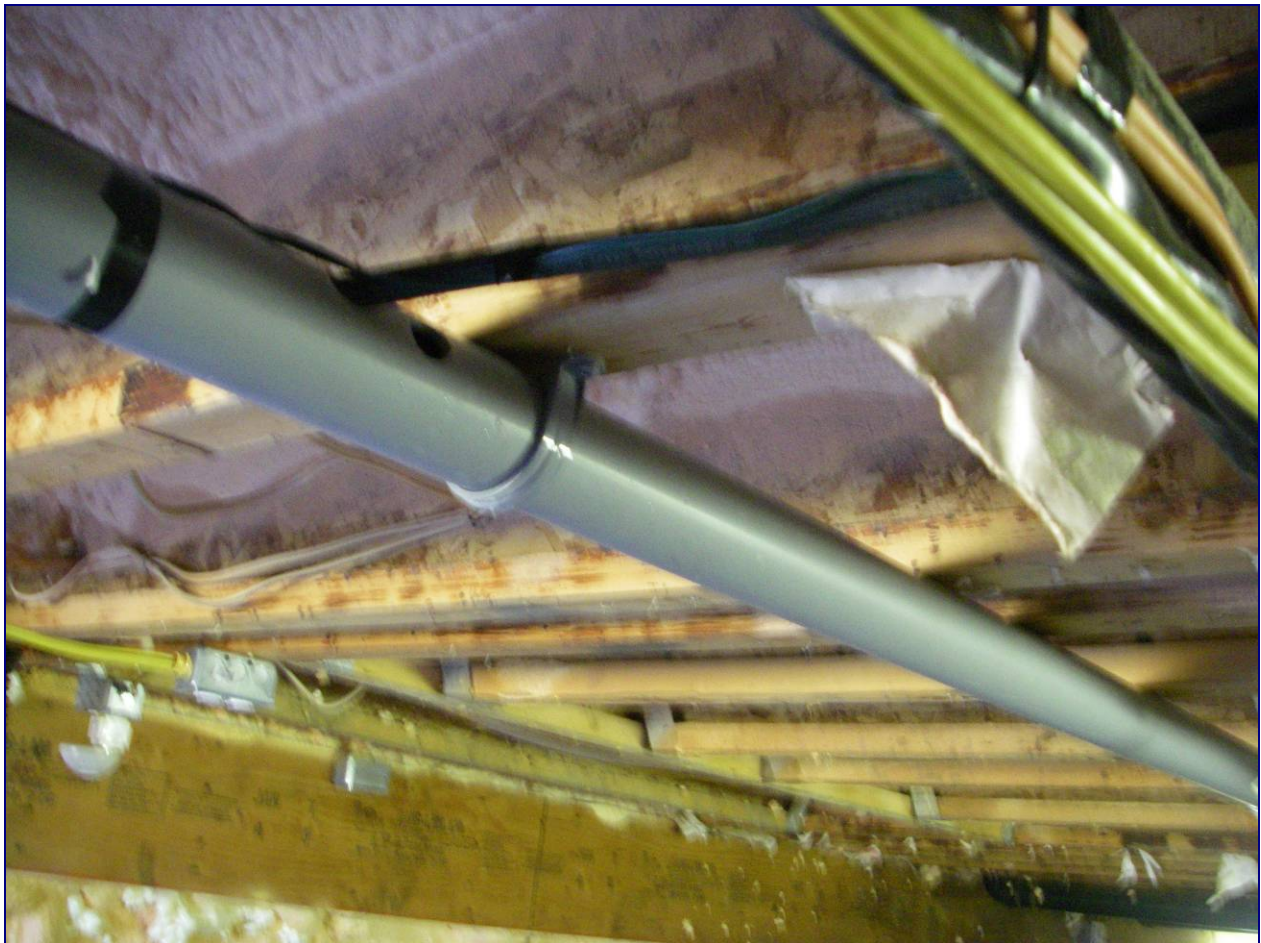
Item #28. west of Calgary, house, off-grid (same PV system as in Item #29, Item #30, Item #31, Item #32)

PV array size: not known
Electrical specs: $V_{batt} = 24 \text{ VDC (?)}$, $V_{inverter} = 120 \text{ VAC}$
Operating status: operating
Inspection status: not known
Installed by: HVAC contractor installing PV systems

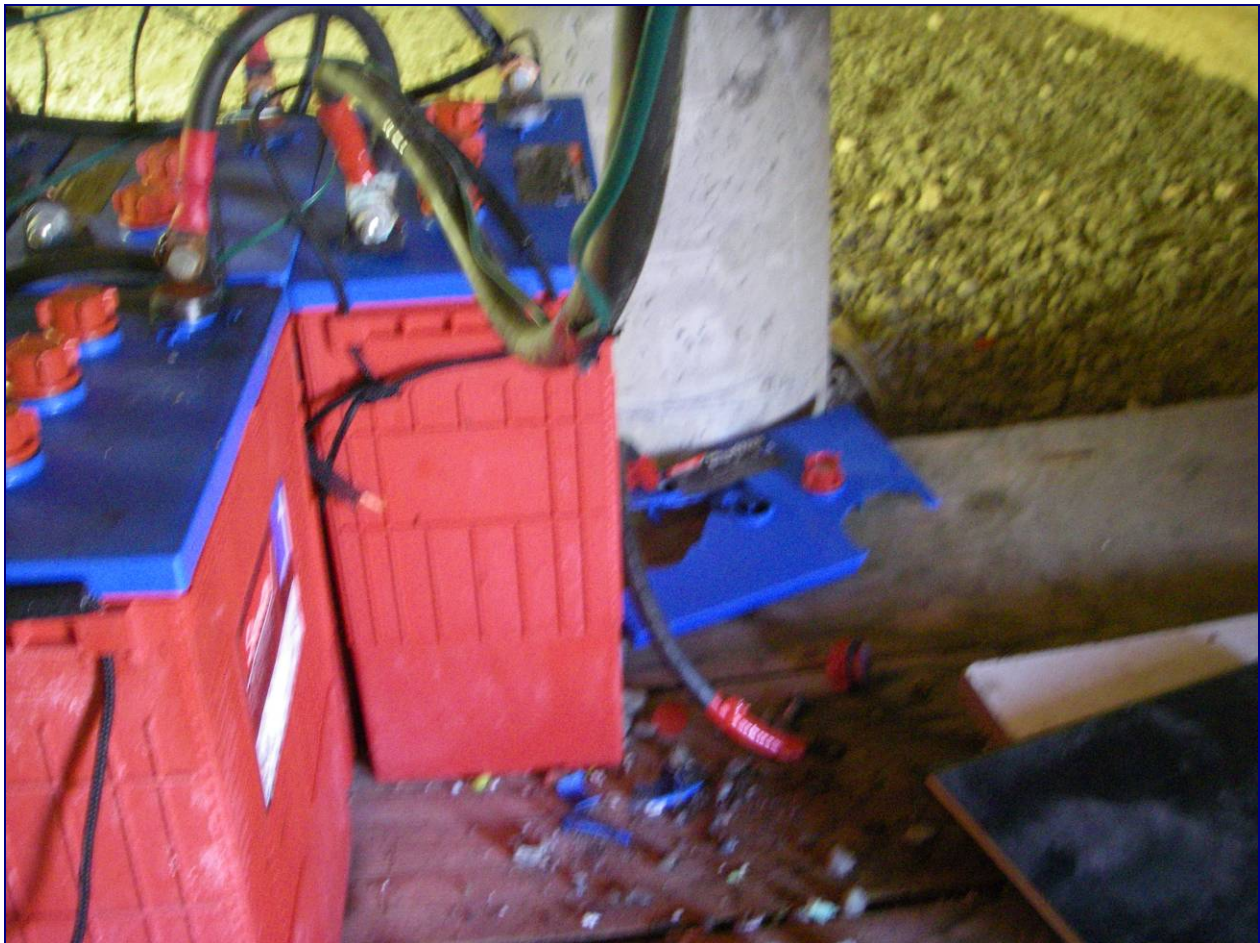
Item #30. **west of Calgary, house, off-grid** (same PV system as in Item #28, Item #29, Item #31, Item #32)

PV array size: not known
Electrical specs: V_{batt} = 24 VDC (?), V_{inverter} = 120 VAC
Operating status: operating
Inspection status: not known
Installed by: HVAC contractor installing PV systems

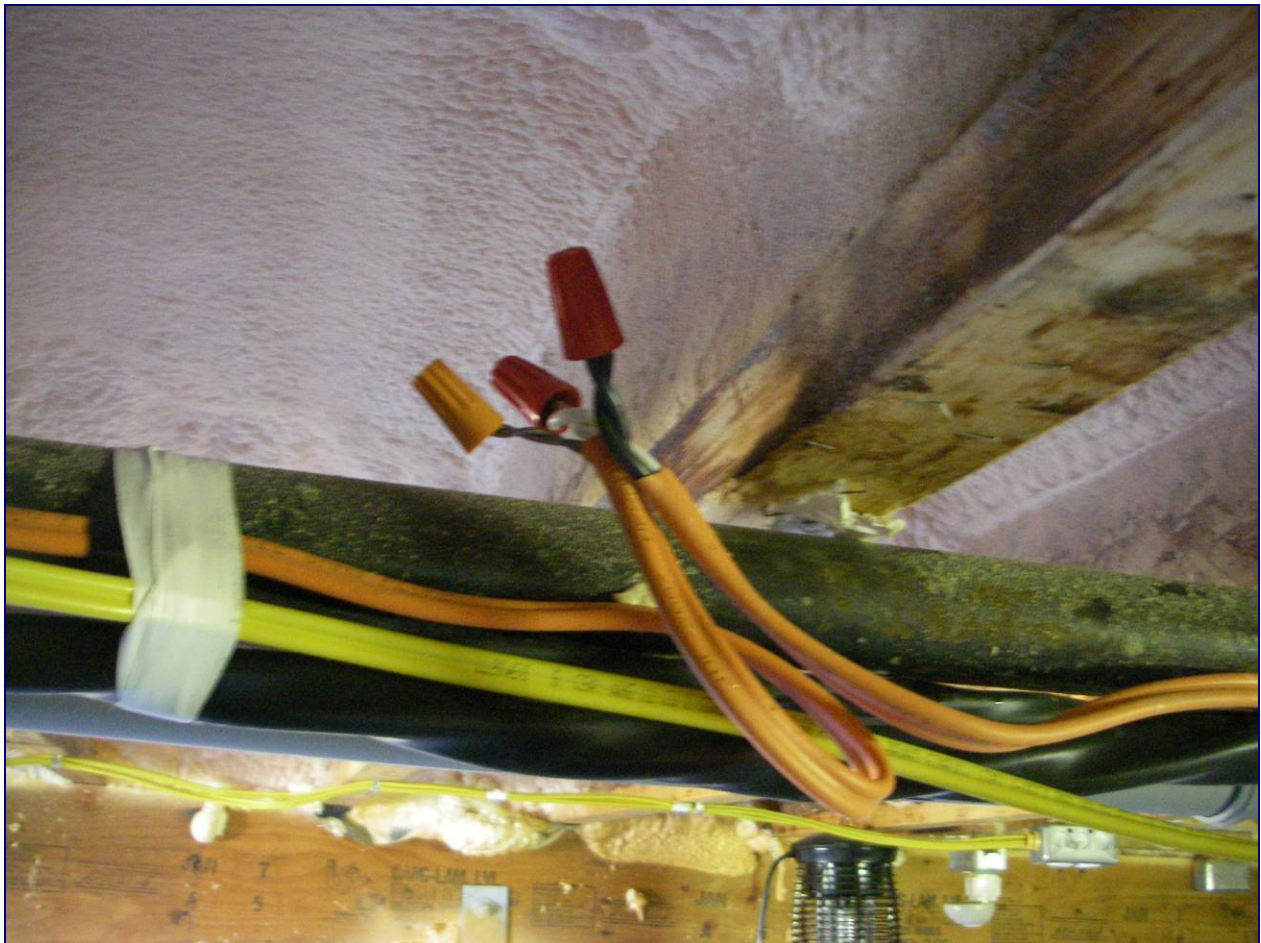
Item #31. west of Calgary, house, off-grid (same PV system as in Item #28, Item #29, Item #30, Item #31, Item #32)

PV array size: not known
Electrical specs: $V_{batt} = 24 \text{ VDC}$ (?), $V_{inverter} = 120 \text{ VAC}$
Operating status: operating
Inspection status: not known
Installed by: HVAC contractor installing PV systems

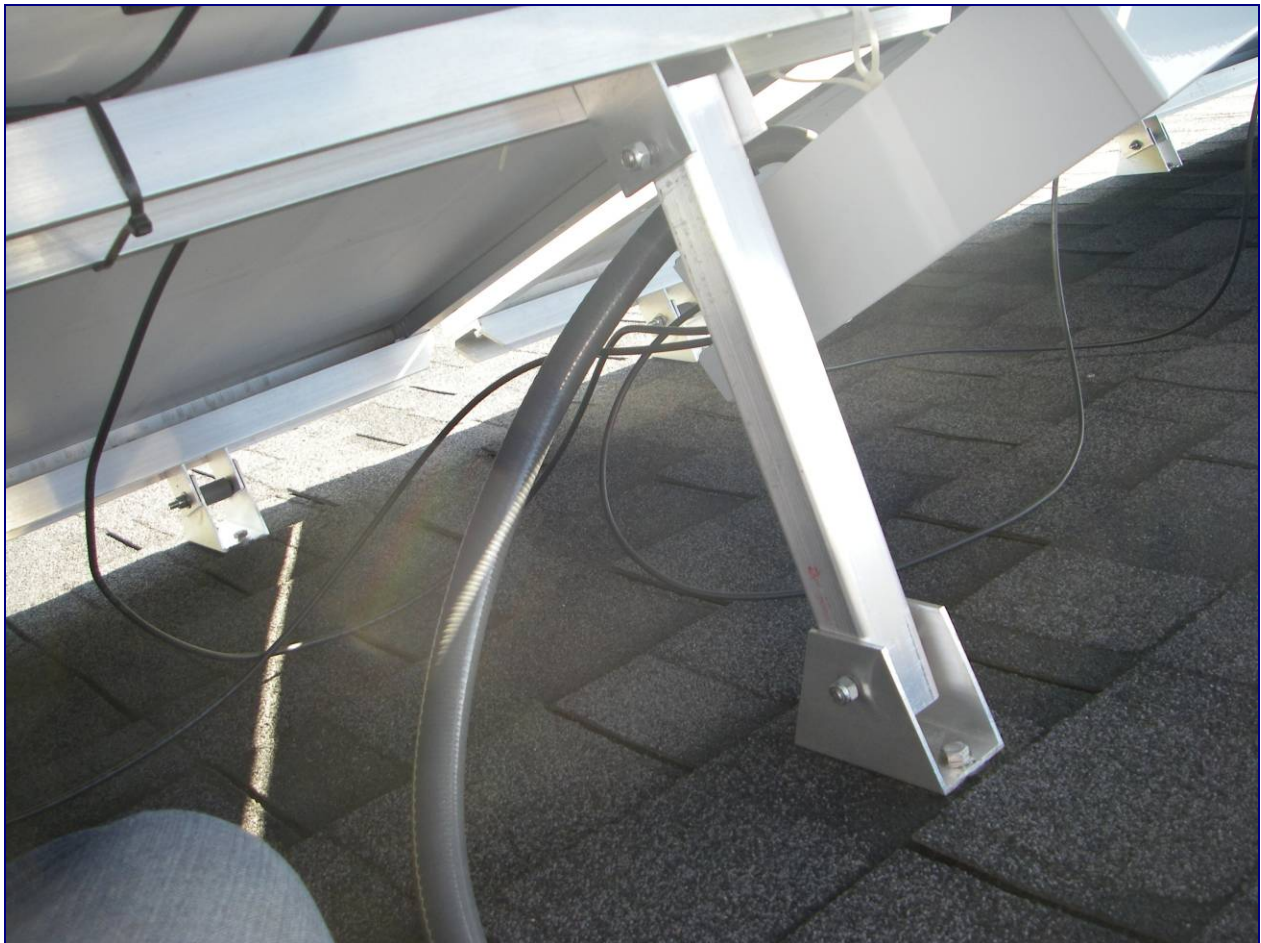
Item #32. west of Calgary, house, off-grid (same PV system as in Item #28, Item #29, Item #30, Item #31)

PV array size: not known
Electrical specs: $V_{batt} = 24 \text{ VDC}$ (?), $V_{inverter} = 120 \text{ VAC}$
Operating status: operating
Inspection status: not known
Installed by: HVAC contractor installing PV systems

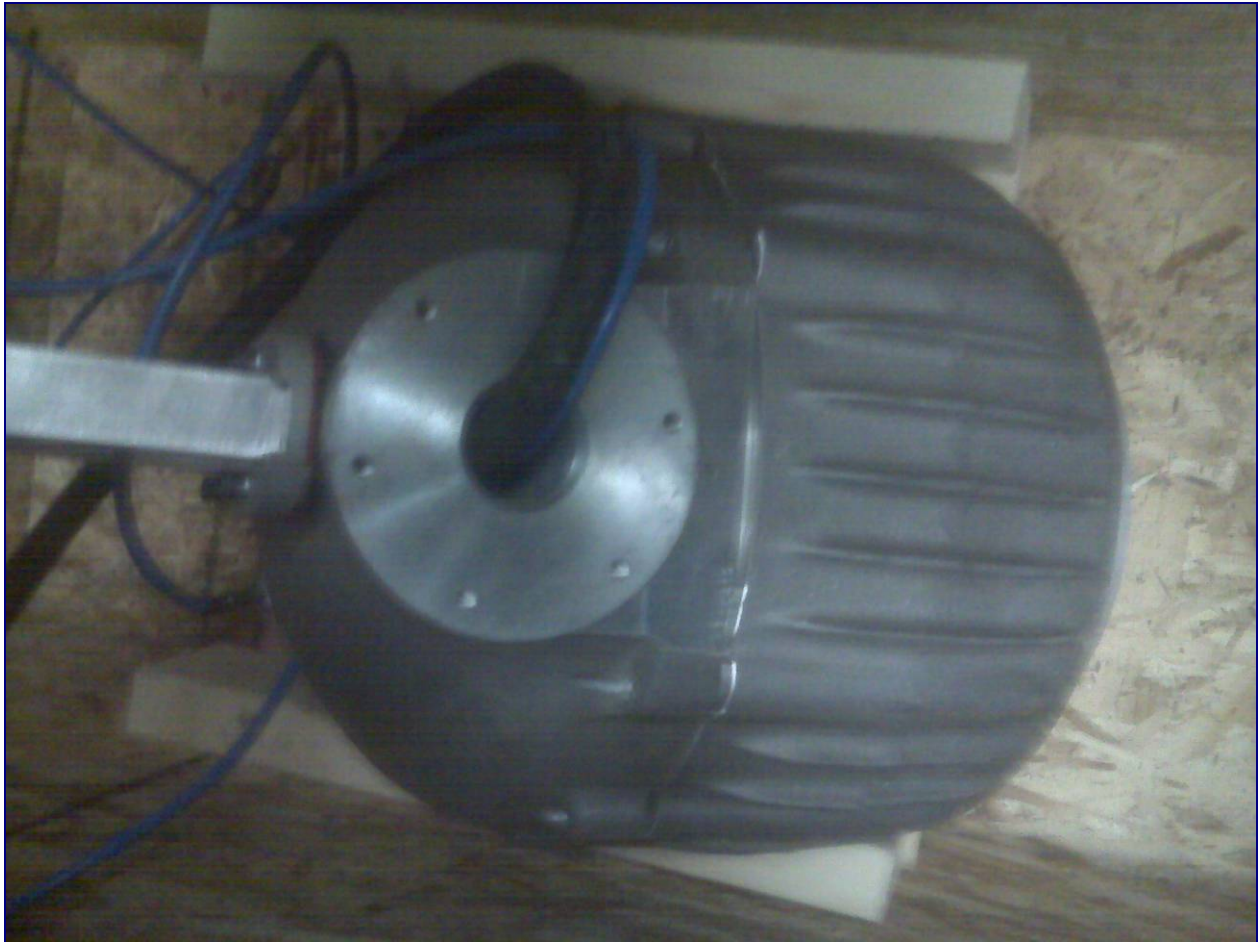
Item #33. near Lethbridge (wind generator)

Generator size: 3 kW (?)
Electrical specs: not known
Operating status: operating since 2010 (?)
Inspection status: not known
Installed by: not known

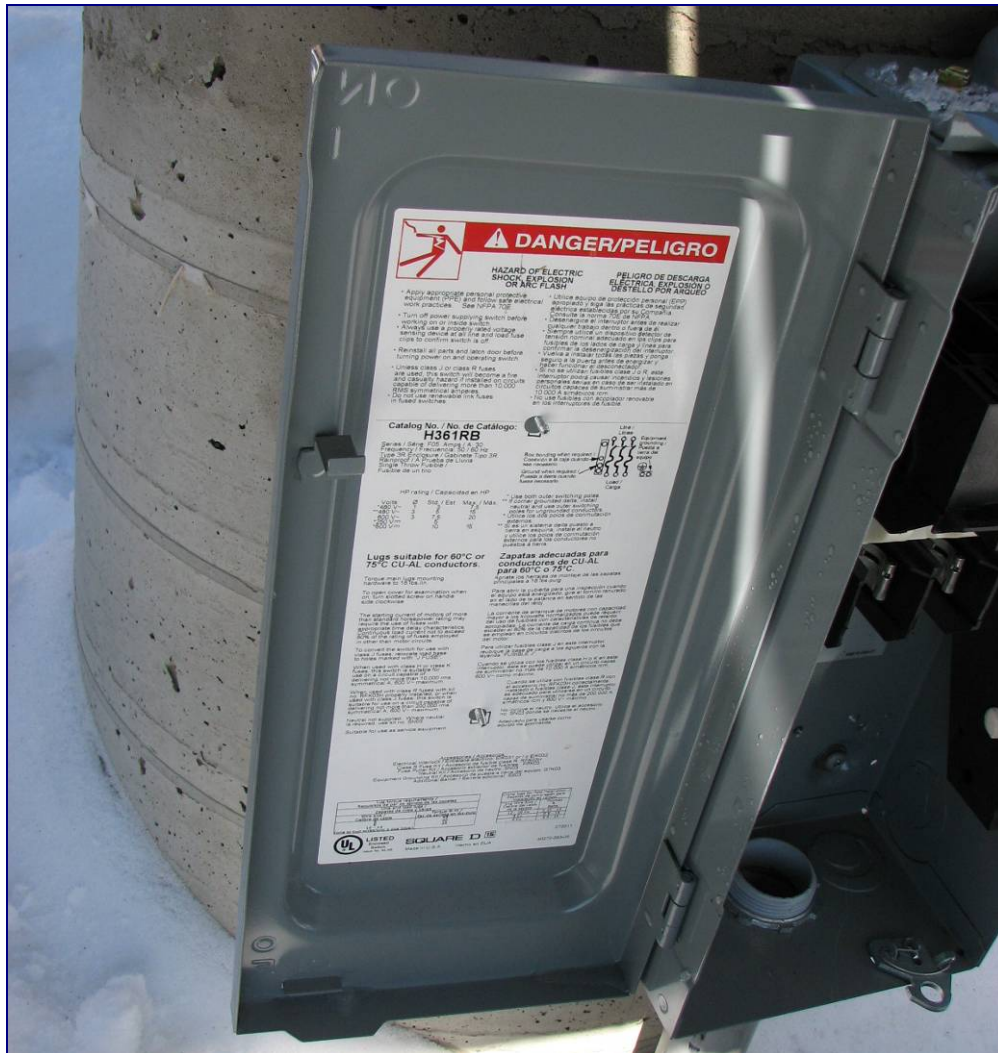
Item #34. Red Deer, municipal building (same PV system as in Item #9, Item #35, Item #36)

PV array size: 1 kW
Electrical specs: Inverter = 120 VAC
Operating status: operating since 2005 (?)
Inspection status: inspected, passed
Installed by: electrical contractor, not PV qualified

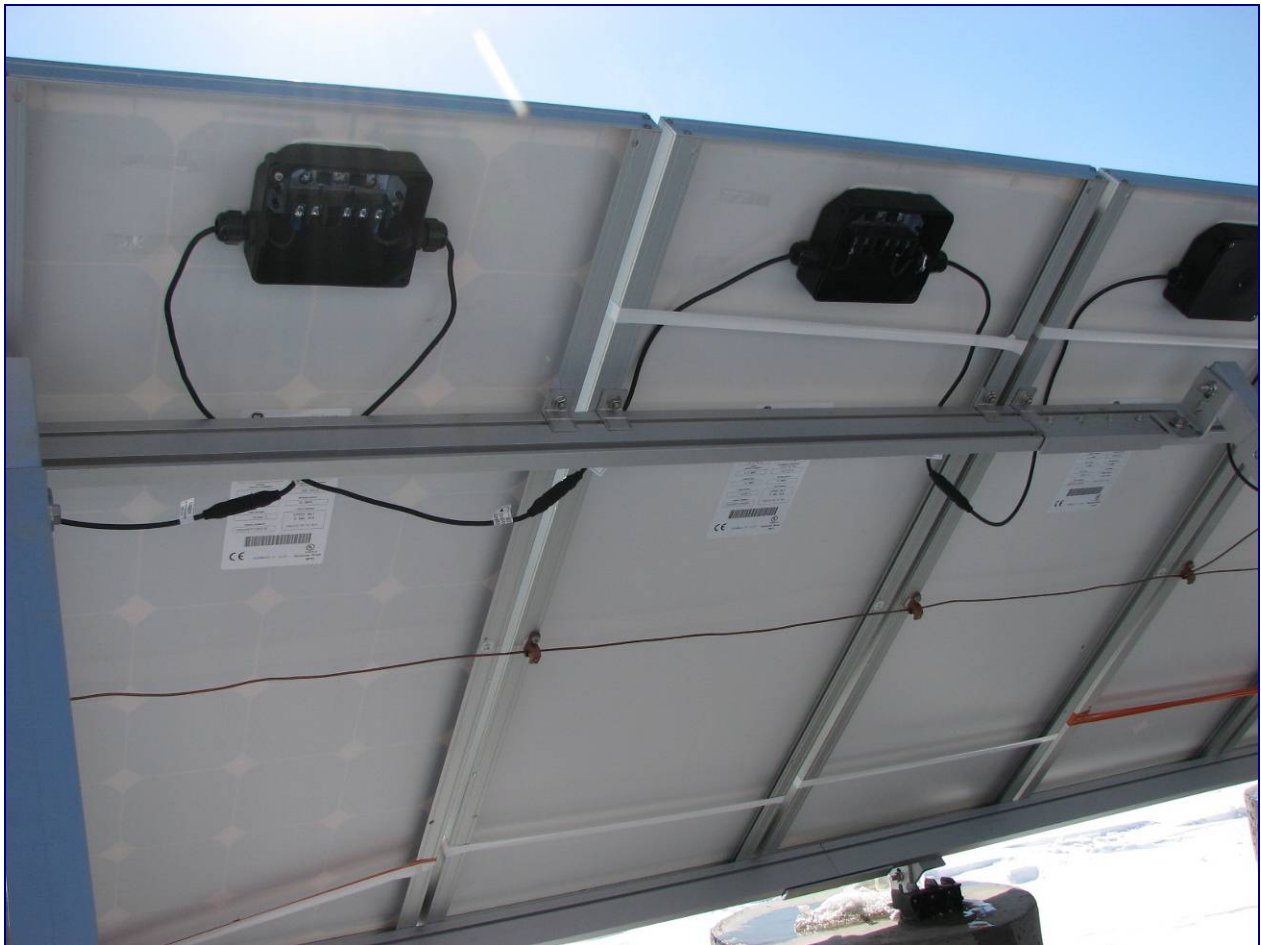
Item #36. Red Deer, municipal building (same PV system as in Item #9, Item #34, Item #35)

PV array size: 1 kW
Electrical specs: VInverter = 120 VAC
Operating status: operating since 2005 (?)
Inspection status: inspected, passed
Installed by: electrical contractor, not PV qualified

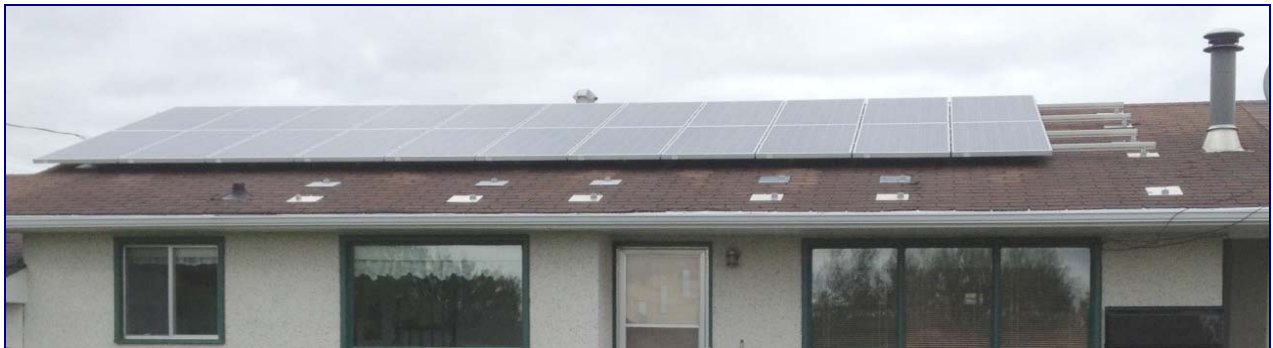
Item #37. Mayerthorpe, house

PV array size: 7.8 kW
Electrical specs: $V_{MP} = 336$ VDC, $I_{MP} = 15.4$ ADC, Vinverter = 240 VAC
Operating status: likely operating
Inspection status: unknown
Installed by: electrical contractor specializing in PV systems

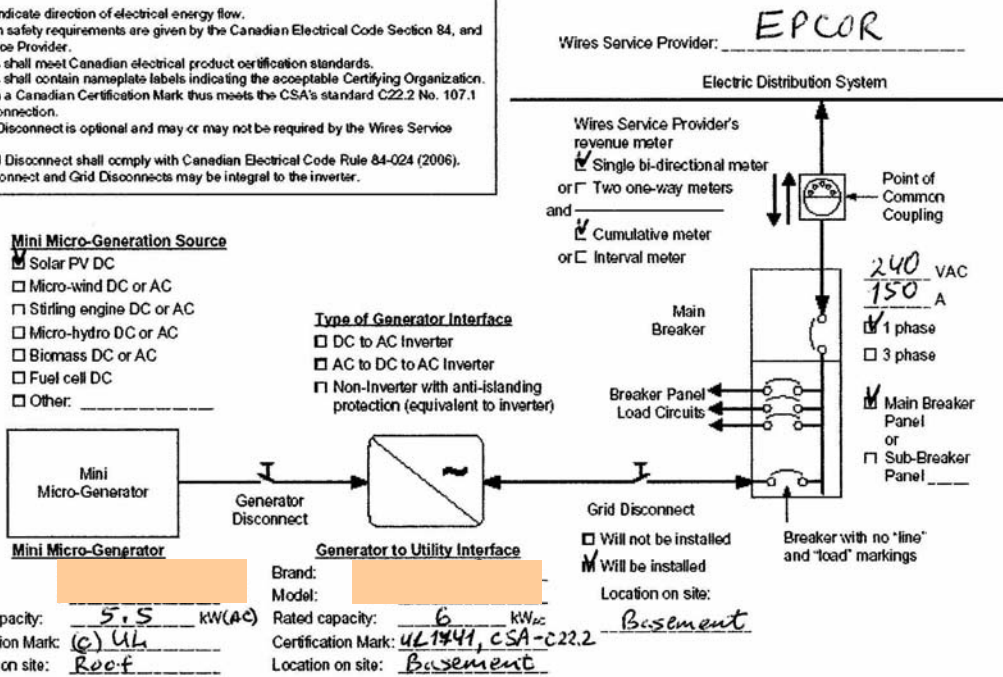
Item #40. Edmonton, house (same PV company as in Item #39)

PV array size: 5.5 kW
 Electrical specs: not known
 Operating status: operating
 Inspection status: likely inspected
 Designed by: electrical contractor specializing in PV systems

APPENDIX E – SINGLE LINE DIAGRAM

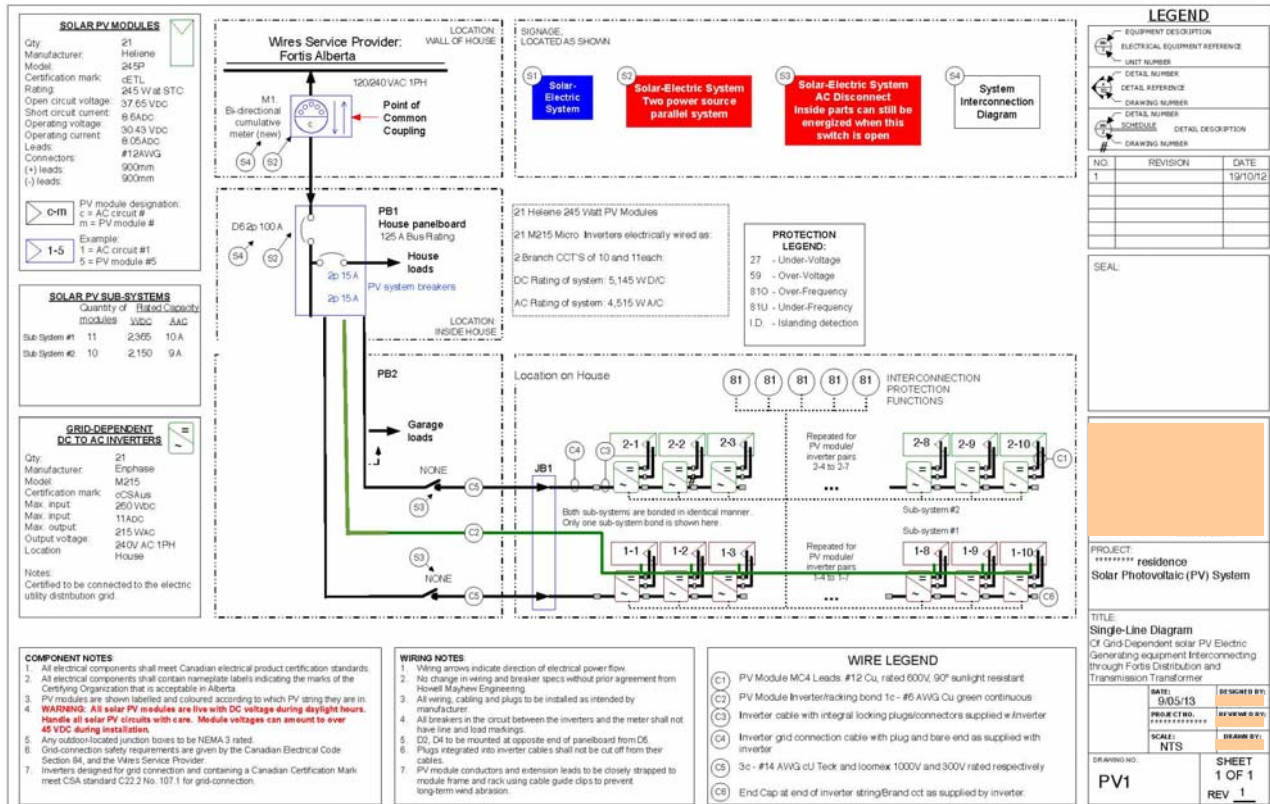
Item #41. Strathcona County, house

PV array size: 4.5 kW
 Electrical specs: Vinverter = 240 VAC
 Operating status: likely operating
 Inspection status: likely inspected

Designed and drawn by: original: professional engineer specialising in solar PV systems; copy: electrical contractor specializing in PV systems

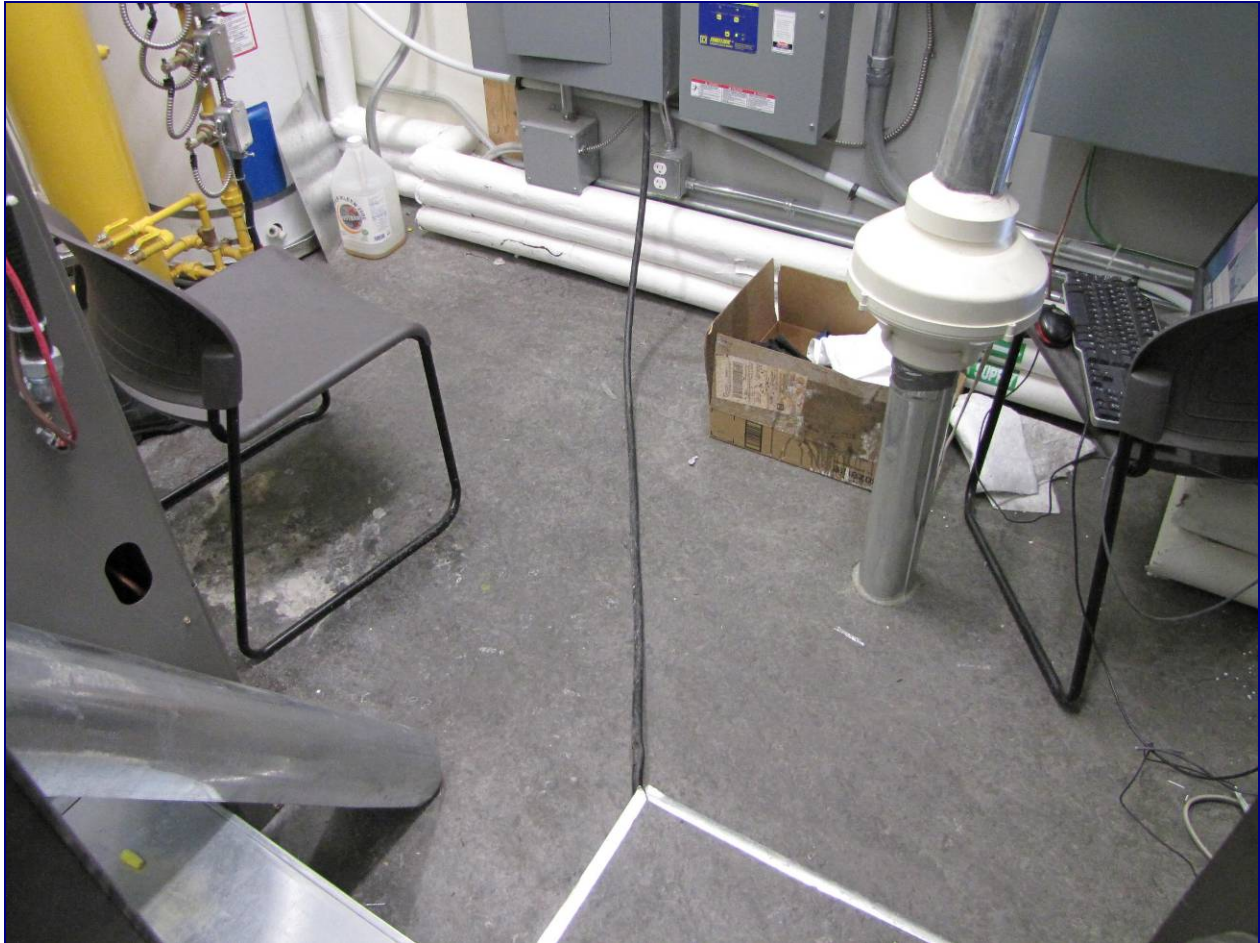
Item #42. Old Crow, Yukon (federal government building)

Electrical specs: V_{cable} = 240 VAC
Operating status: operating since 2012
Inspection status: not (permit? not)
Installed by: handyman
